COMPLEAT IDIOT'S GUIDE TO IVECO DAILY 4X4 55S17W

2020 REVISION

About this Book

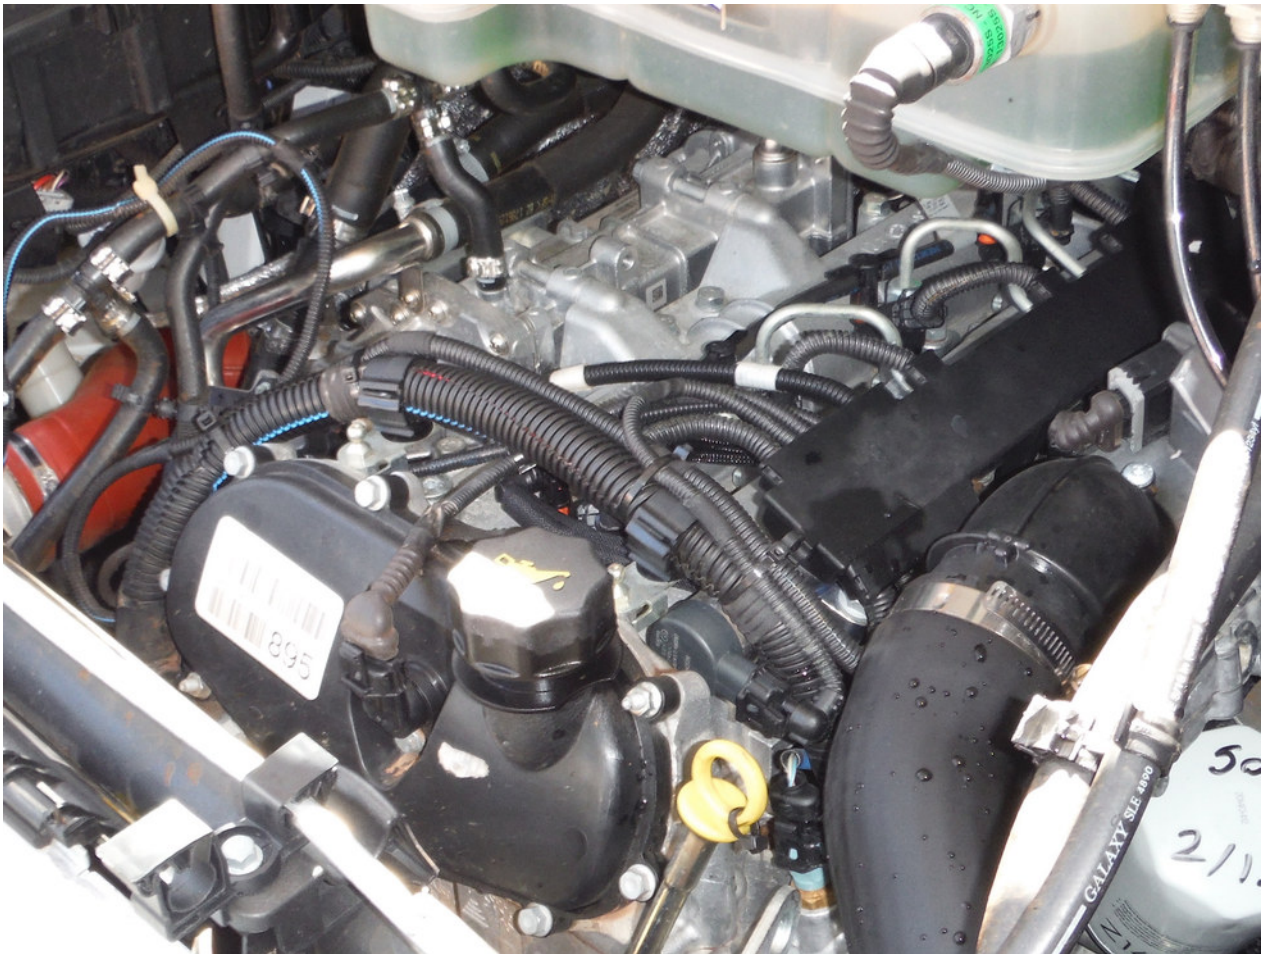
ENGINE

The engine used in the Daily 4x4 is the outstanding 3.0 liter FIC made by FPT (Fiat Powertrain Technologies) which was introduced in 2006. This engine is a Common Rail Diesel, DOHC 4 valves per cylinder. The twin camshafts are driven by double and single row chains.

The Euro 5 version is fitted with Borg-Warner compound (twin) turbocharger. The small turbine is Waste-gate controlled and the large is a fixed compressor. A very reliable turbo setup. Earlier Euro 4 & Later E6 versions have a single VGT.

Torque Output is 400Nm across the useable rev range from 1200 to 3500RPM and 170 HP (125Kw). Engine is ECU governed at 5500RPM.

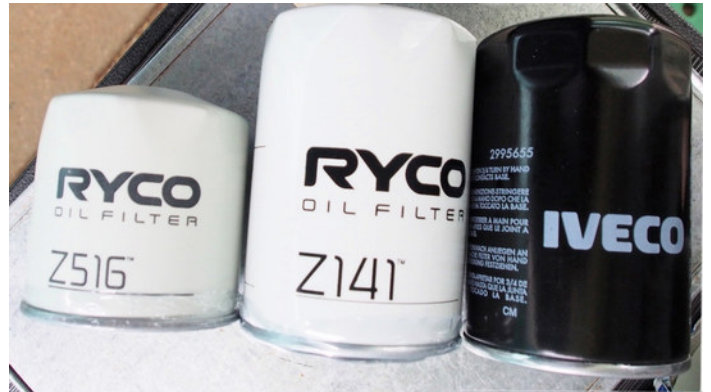
Genuine Filter Iveco Part no. 2995655
Ryco Z141 / Ryco 516

The oil filter is torqued down, removal of the filter will require a cam action or webbing wrench with a top mounted ratchet drive handle. Fit new filter till it is in contact with the housing then tighten 3/4 of a turn. Oil filter tightening torque is 25Nm

It has been found that the use of a smaller capacity filter results in faster oil pressure build up on a cold engine start, faster pressurisation of the hydraulic cam chain tensioner and hydraulic lifters minimises the cold start rattle, and associated engine wear. Use of the smaller filter will necessitate more frequent oil changes @ 10,000 - 15,000 km, and that can only be a good thing.

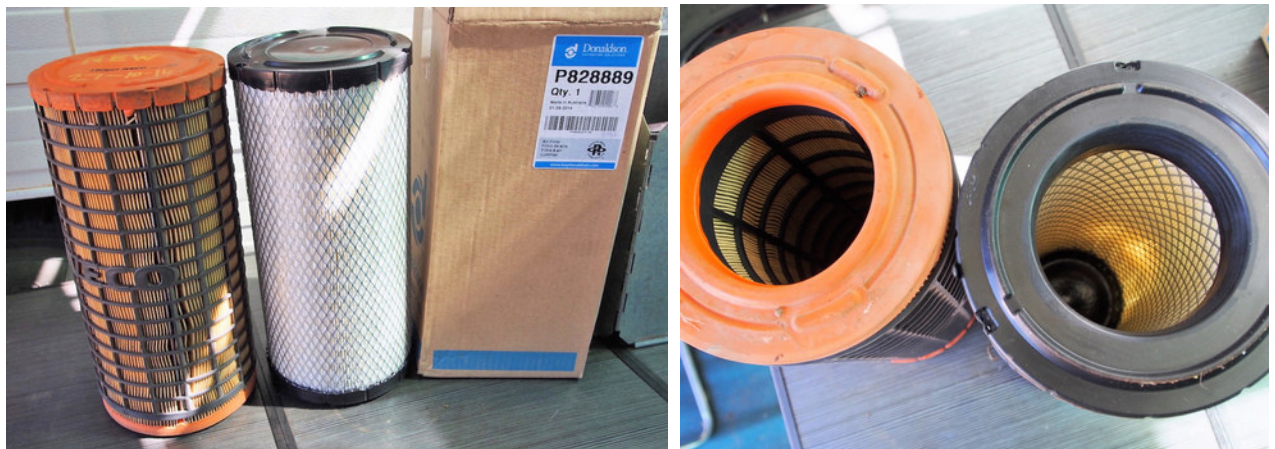
Air Filter

Genuine element is Iveco 1903669 , about \$85.00 locally (made in Italy)
Donaldson P828889 , \$45 (made in Australia or China)
Wesfil WA5019

Comparing the filters side by side the Donaldson looks and feels much better quality. The Iveco has a plastic cage to contain a paper filter media, Donaldson has expanded steel mesh enclosing a water resistant cellulose media. The Donaldson has approximately 20% more media surface area, with 12 pleats for every 10 on the genuine filter. Also the orange "silicone" that the Iveco filter is encased in easily breaks apart, its more like a dense sponge than a silicone rubber. A comparison of the two clearly shows the Donaldson filter to be more than acceptable for use in the 55S17W. If Iveco frown on you using this cartridge they are being Obtuse.

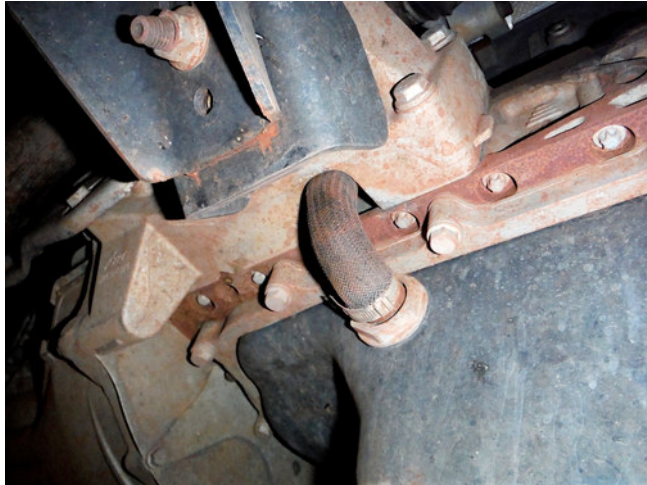
bottom (big) turbo oil return

Something to keep an eye on, the oil return line from the top turbo has required attention on some vehicles. The bottom turbo oil return hose drains directly into the sump, the Top return hose drains into the block as shown in the image to the right.

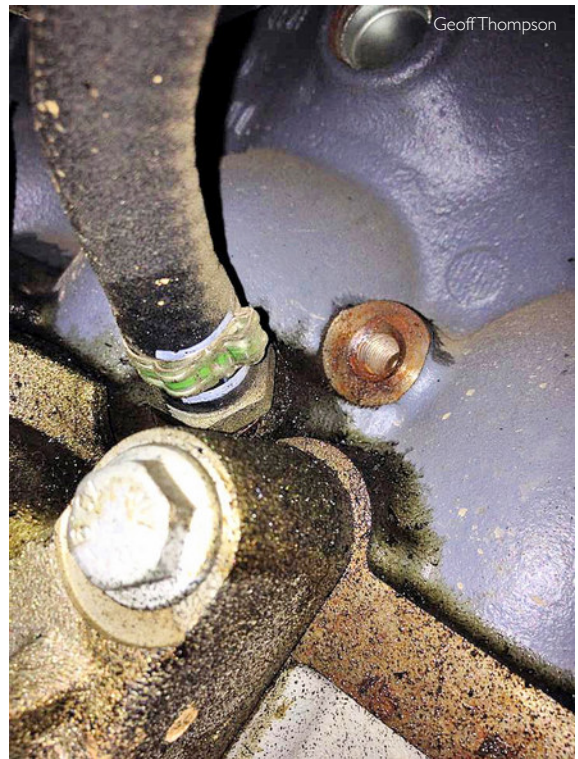
top (small) turbo drain hose

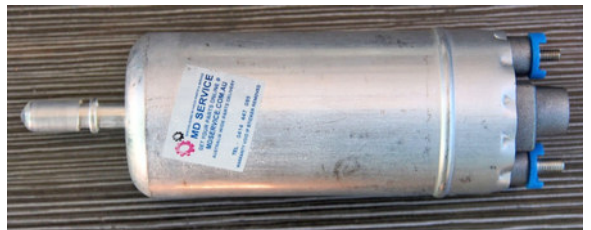
This pump has a brush motor energised by permanent magnets, it is mounted on the suction pipe, on the left-hand side of the chassis frame. It has a check valve to prevent the fuel circuit from emptying (with the pump stationary) and an overpressure valve that recirculates the delivery with the inlet when pressures over 5 bar are produced. Delivery pressure: 2.5 bar > 155 litres/h
Coil resistance at 20°C: = 28.5 Ohms

Iveco Part no. 69503673 Bosch 0 580 464 127

The fuel pressure regulator is situated on the CP4 HP Pump body (seen at top in the photo above) in the low-pressure circuit. The pressure regulator meters the amount of fuel delivered to the high-pressure circuit according to the commands it receives directly from the ECU. The pressure regulator is normally open unless it is receiving any input signals, in this condition, the pump will be delivering its maximum flow rate. The engine control unit varies fuel delivery in the high-pressure circuit by partially closing or opening the fuel pipe sections in the low pressure circuit via a PWM signal

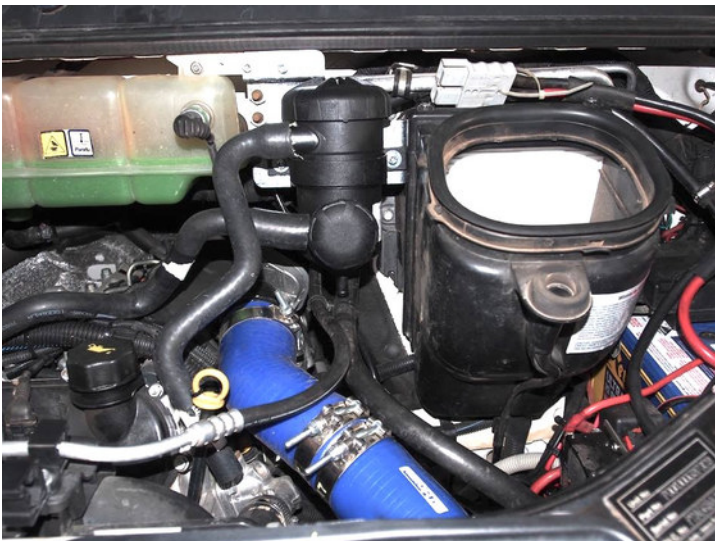
Provent 200 PCV unit installed on firewall

One preventative strategy is to remove the filter and PCV valve from the PCV housing and retrofit an aftermarket PCV Filter such as Mann&Hummel Provent 200. Ironically Mann & Hummel make the PCV filter in the rocker cover of the smaller Iveco FIA engine .

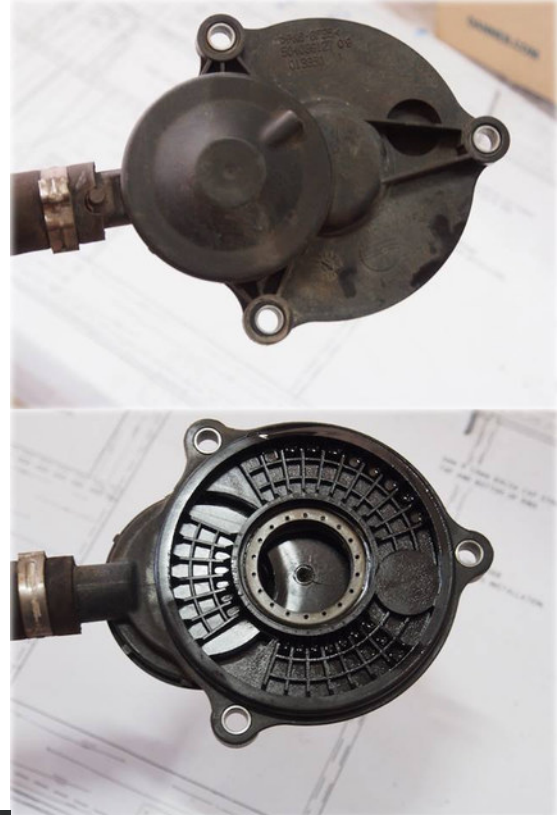
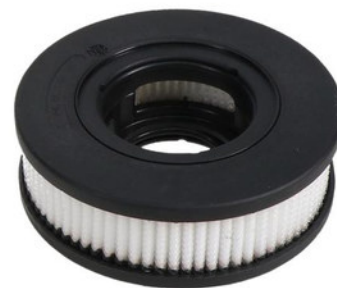
PCV filter cartridge, part 504075145

Iveco recommend the PCV filter is changed at 200,000 km. intervals. In service these tend to fail at about 100,000 km. with no apparent symptoms, but should be serviced every 50,000 km. When the filter blocks oil fumes are sucked through the intake duct and can pollute the turbocharger, boost hoses and intercooler. If the oil fumes migrate into the intake manifold & mix with carbon particles from the EGR which can reduce the performance, efficiency and longevity of your engine.

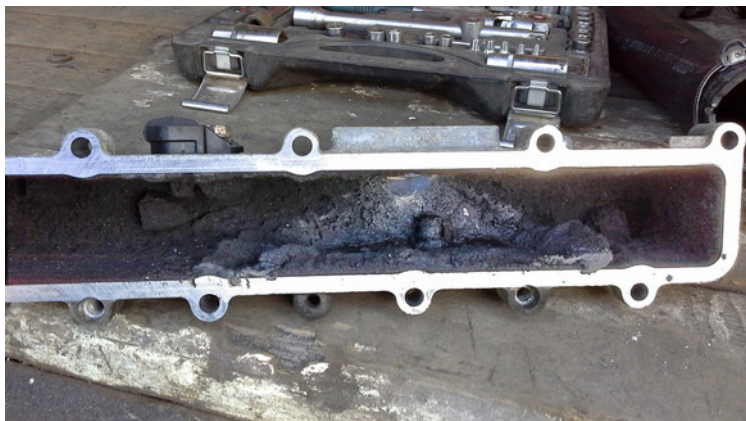
Soot build up inside Iveco F1C Plenum - inlet manifold , EGR error 148.

Almost one Kg of soot removed from inlet tract of this Iveco F1C, ...images courtesy Pavel Shcherbakov ...drive2.ru

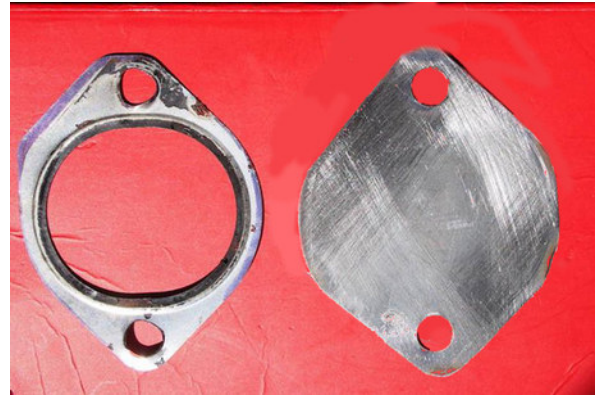
EGR gasket and "full" blanking plate

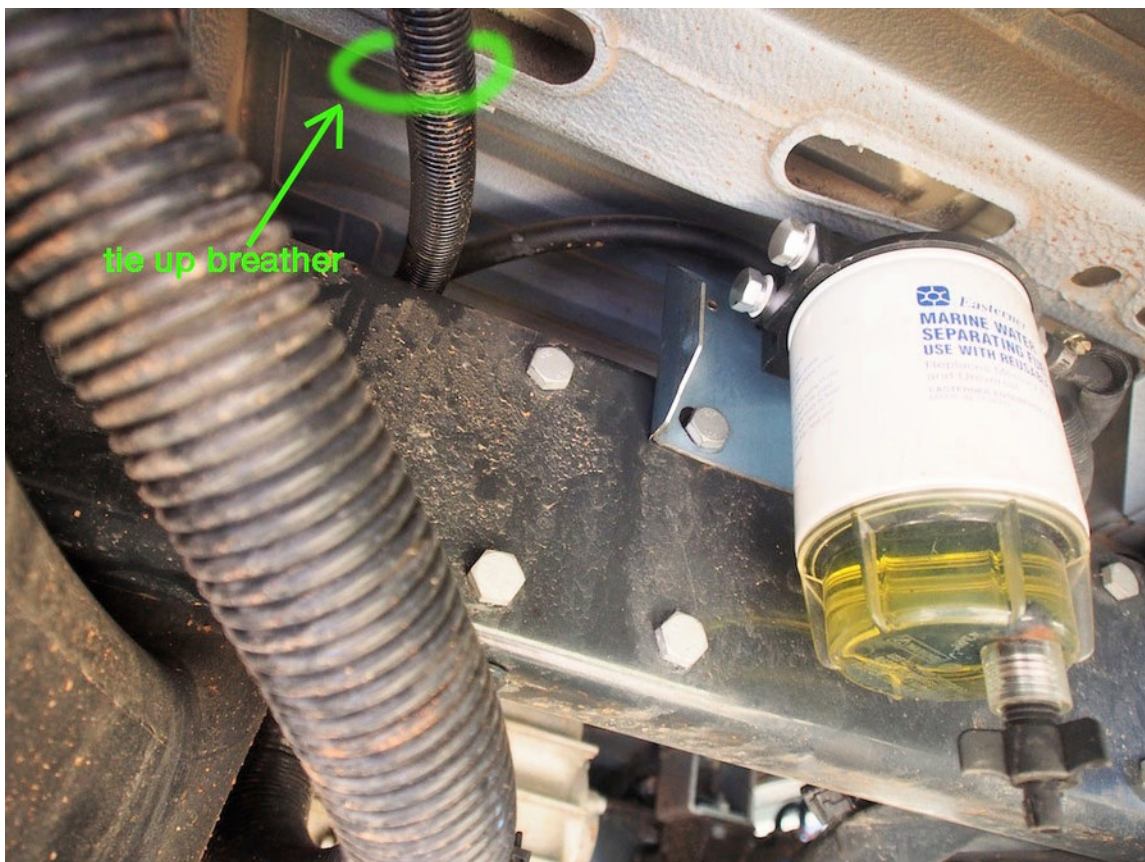
Aftermarket Racor style pre-filter - sedimenter

It is a good strategy to replace the small gauze 'pre-filter' with an aftermarket sedimenter-water trap. Any Diesel water trap filter such as Racor, Donaldson, Fuel Manager that allows flow rates of 150L/hr or 2.5L/pm will be adequate. The filter / sedimenter is to be installed in the low pressure suction line, a so called "CRD high pressure filter" is un-necessary.

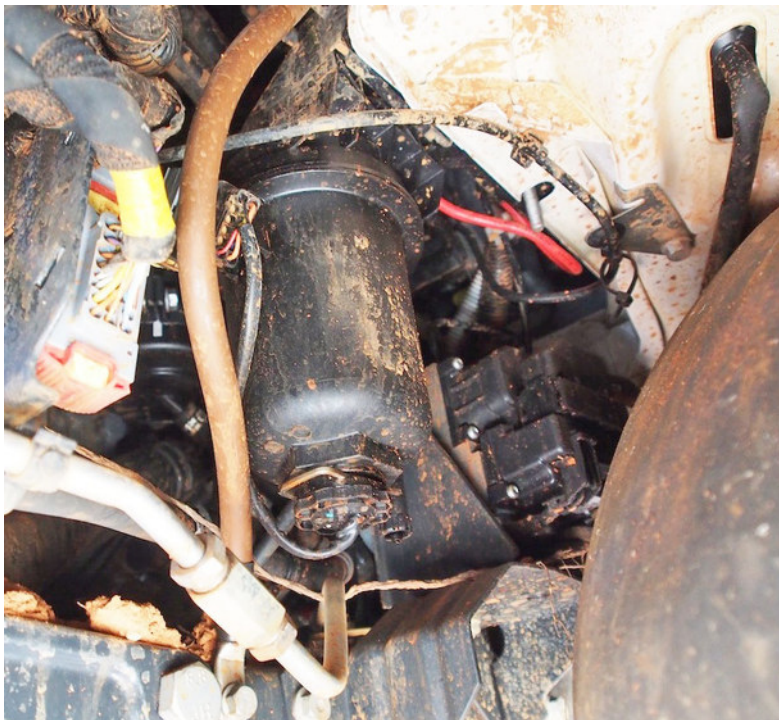
The main fuel filter is located beneath the battery and is accessed from underneath by removing the inner mudguard. The UFI Filter housing 'electronic unit' incorporates the fuel temperature sensor; a clogging sensor and drain cock. A dashboard error light will illuminate if moisture is detected. Routinely drain the sediment bowl. The fitment of a pre-filter will prolong the life of the UFI filter.

Iveco Part no.	500054702
Mitsubishi	MK667920
Ryco	2705P

The element is the synthetic media cartridge type and being difficult to access, it makes sense to install a good pre-filter if for no other reason than to extend the life of the main filter. The Main filter is in very inconvenient location to perform your weekly fuel filter check as prescribed on page 220 of the users manual.

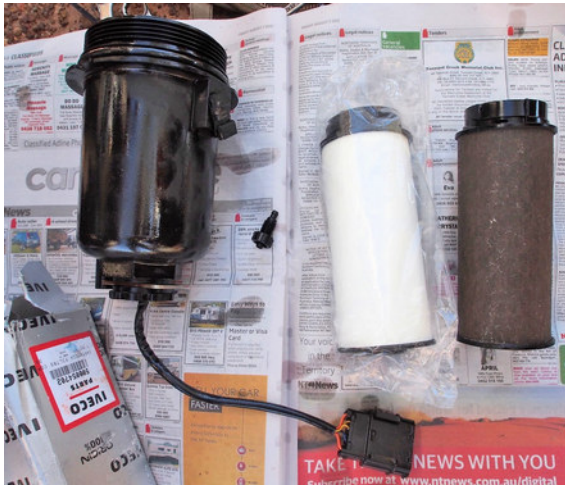
New filter vs Dirty, (allegedly changed by dealer 20k ago)

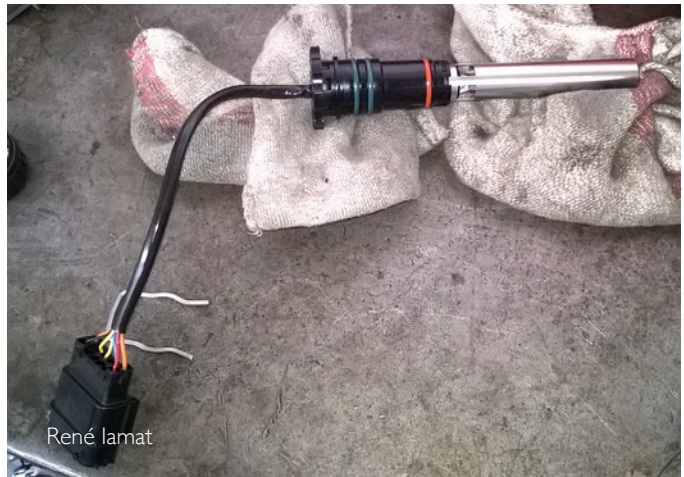
When servicing fuel system meticulous cleanliness is required, like you have OCD! The electronic unit sits in the 'clean' side of the filter, introducing the smallest particle of dust can destroy the HP Pump or Injector, so place the Electronic Unit inside a ziplock bag - not resting on a dirty rag (*per photo above*) as is often the case at an Authorised service centre.

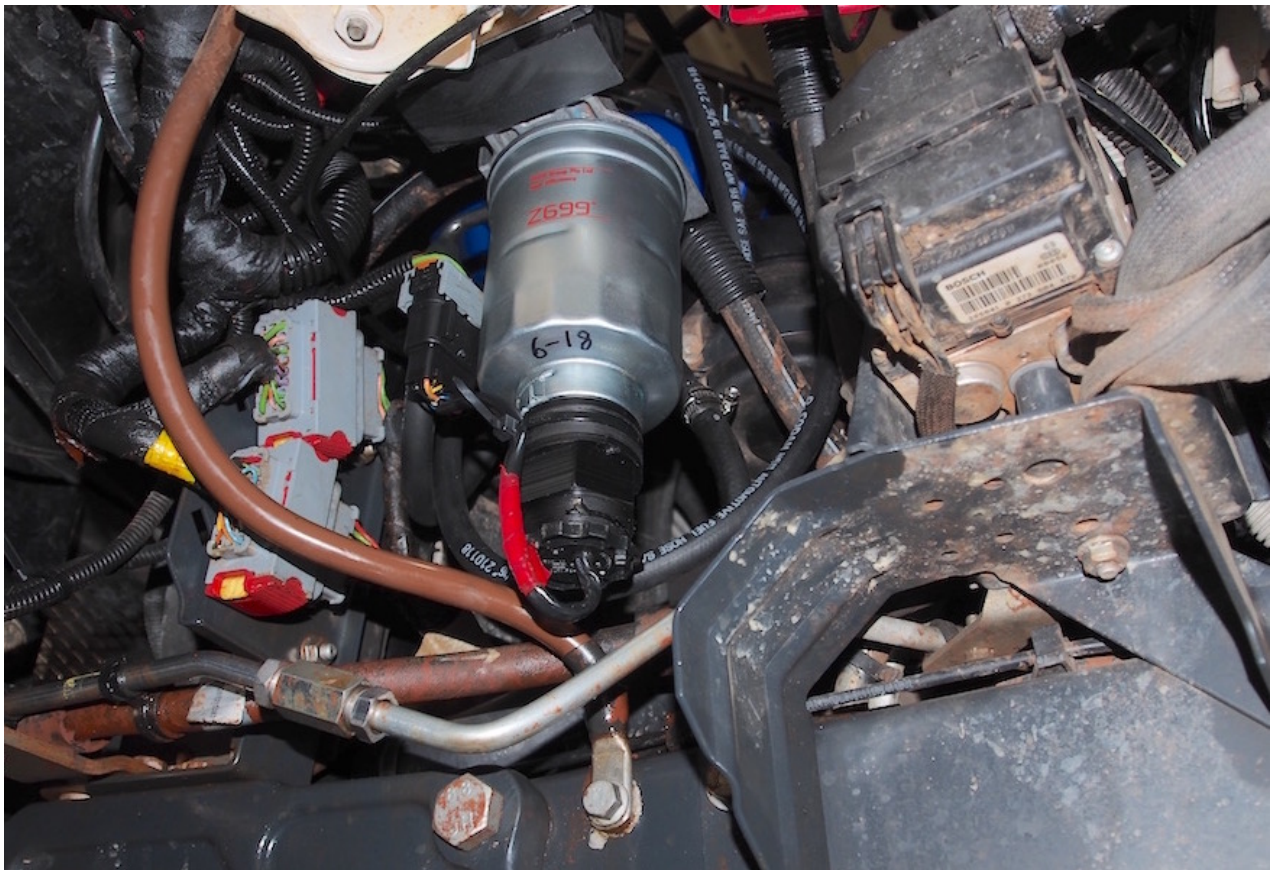
LandCruiser CRD Z699 spin on filter with Iveco sensor adapted.

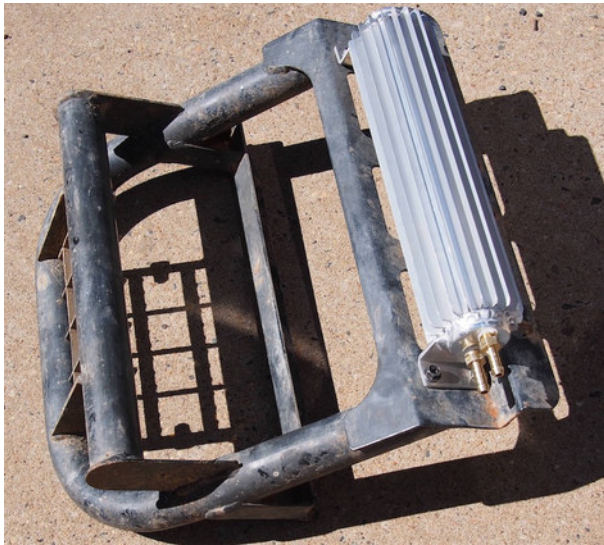
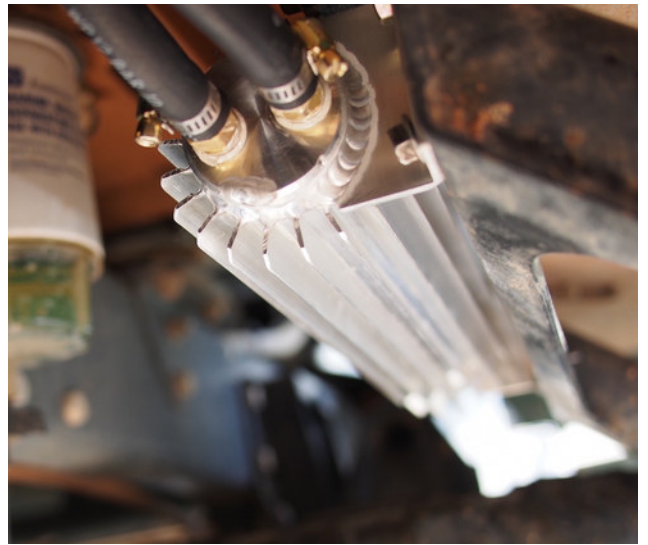
Dual Pass 12" finned alloy transmission cooler makes a great fuel cooler, fits under dual cab rear step

A fuel cooler should only be installed in the return fuel line, definitely not the pick up line, a cooler has much better thermal efficiency at higher temperatures. The return line exits the Fuel Pressure Regulator at the back of the Fuel rail (rear of engine) and runs along the left chassis rail entering the top of tank in the sender / pickup assembly.

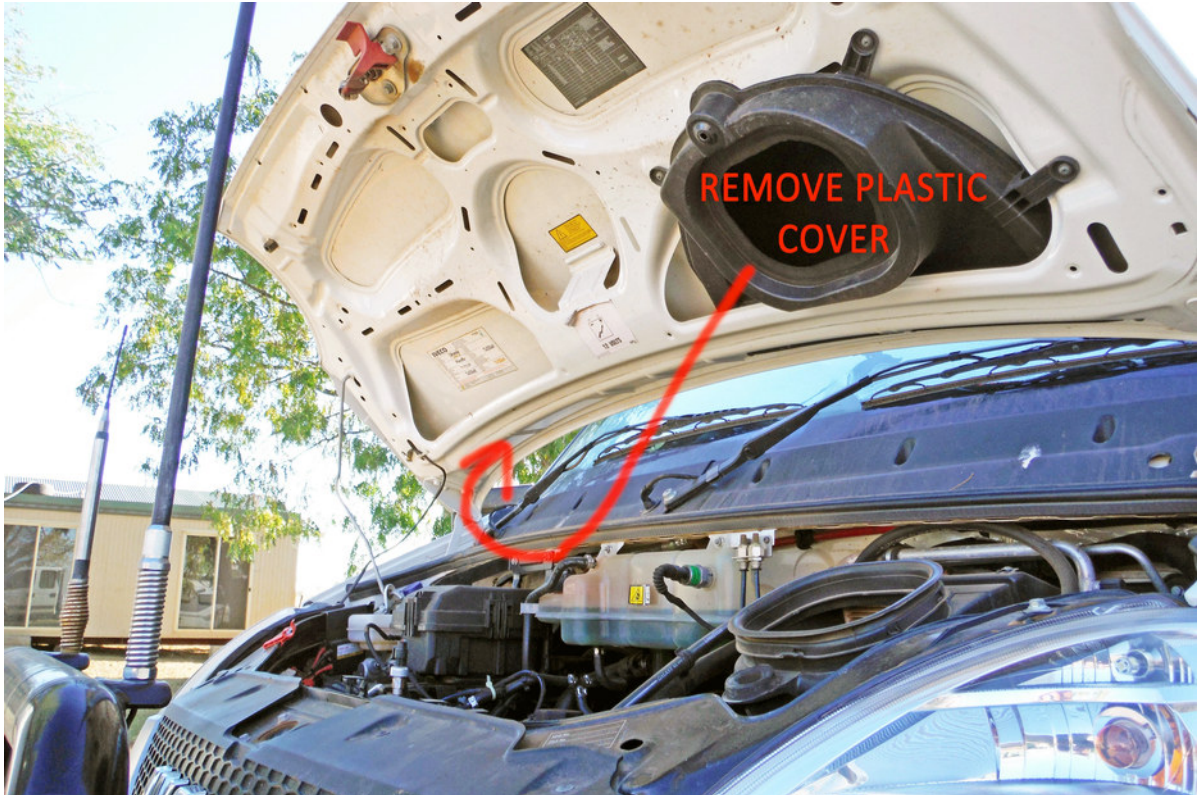
There is a plastic blanking cover, at the rear of and under the right side of the bonnet, it is where the cabin filter on Left hand drive models feed from, this can be pressed out without tools, and can aid hot air to escape the engine bay during low speed and Four Wheel Driving.

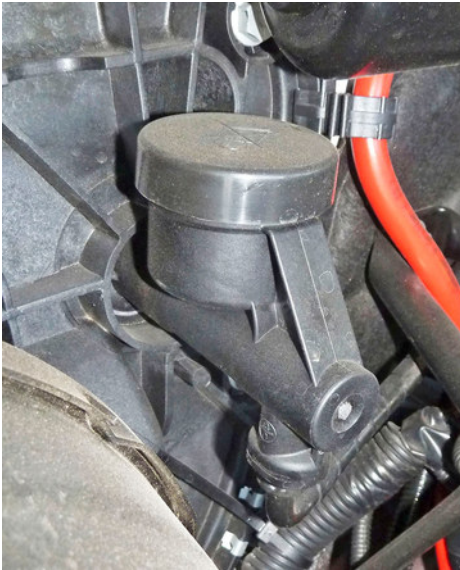
The clutch hydraulics on the 55S17W is a fully sealed unit, with no serviceable parts, as per the side note on page 229 of the Owners Handbook, the master cylinder cap must not be removed. The master cylinder, slave cylinder, and hose is all one part, and comes sealed with synthetic fluid, pre bled, and ready to use upon installation. Part number 5801386404

Clutch hydraulic system - all one part

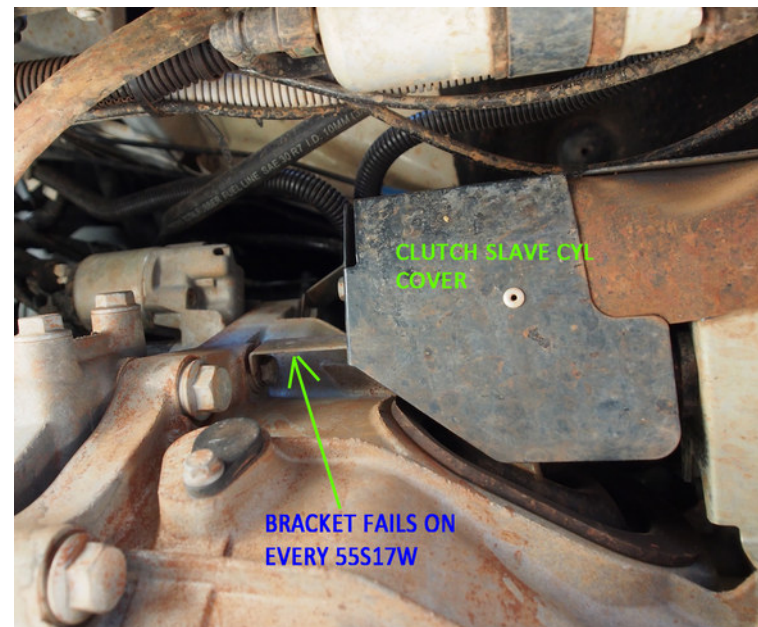
A protective stone guard bracket under the slave cylinder is prone to fatigue cracking and is responsible for an annoying buzzing rattle under the vehicle.

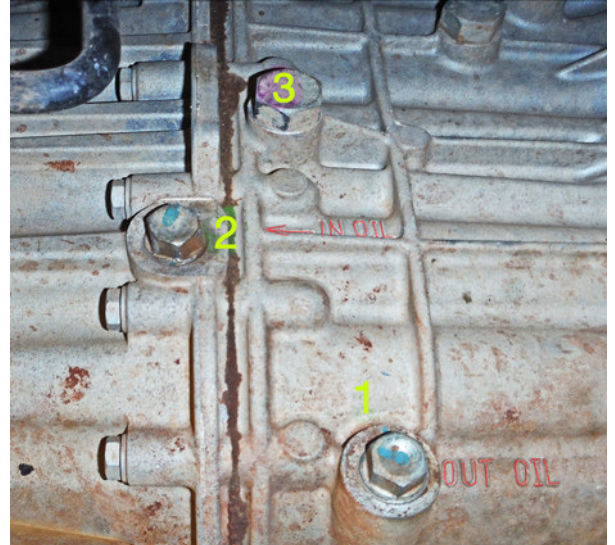
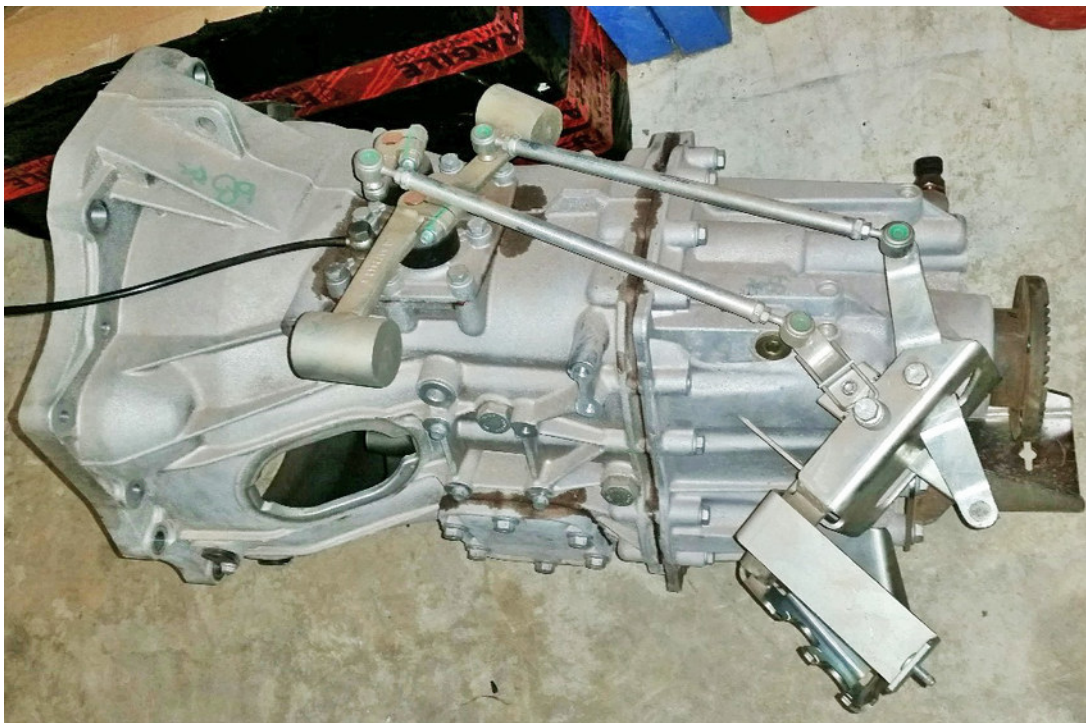
The main gearbox is the tried and tested ZF 6S 400 OD, designated as such for 6 speed, 400Nm (torque input) and OD for Overdrive / cable operated gear shift. It has facility for one PTO drive connection. A proven gearbox, with regular oil changes should not give any trouble for the life of your truck, no reported problems towing in 6th gear.

ZF 6S 400 OD as removed from 55S17W

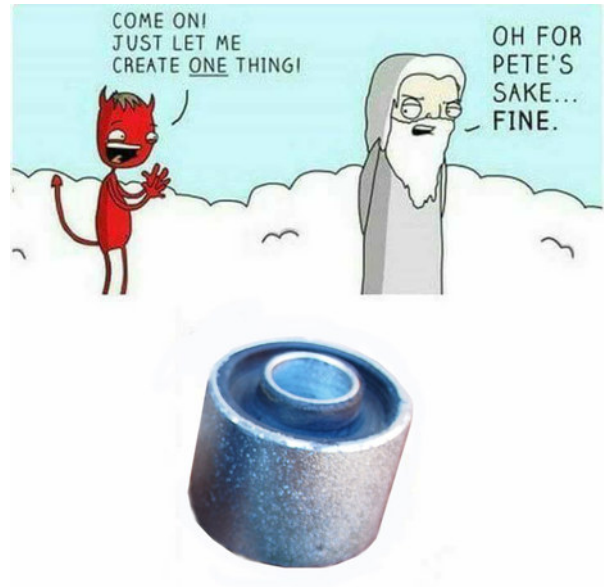
The transfer case is mounted with 3 "Silentblock" bushes, part number 42559937

Failed transfer case silentblock bushes are the cause of a rumbling vibration when pulling away from a start on an incline or under load. In some cases the vibration has been misdiagnosed as clutch shudder.

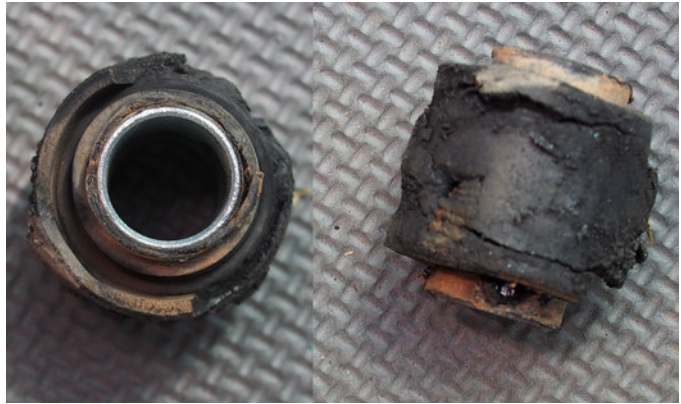
Above rear mounting bush was in a vehicle presented for service at 20,000km, problem not resolved. At 40,000km the Iveco Service centre was asked to check and replace Transfer Case bushes if necessary. Service centre "checked" and reported 'no problem'.

At 45,000km the vibration and clunking was excessive and a decision was made by the owner to fit a polyurethane bush rather than a genuine bush, knowing a genuine bush is 'not fit for purpose'

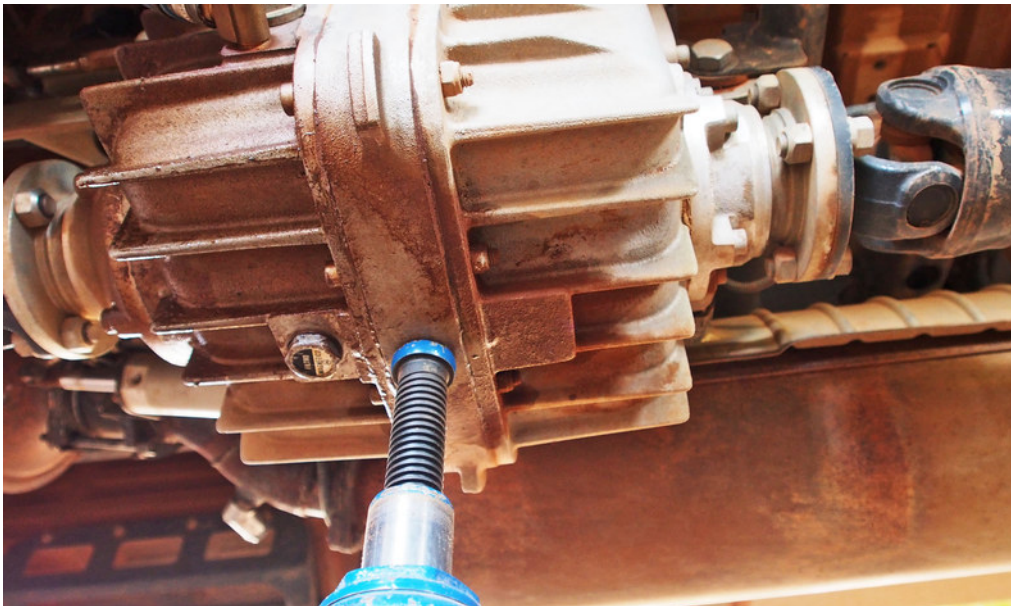
for examining TC bushes only, position jack in this location

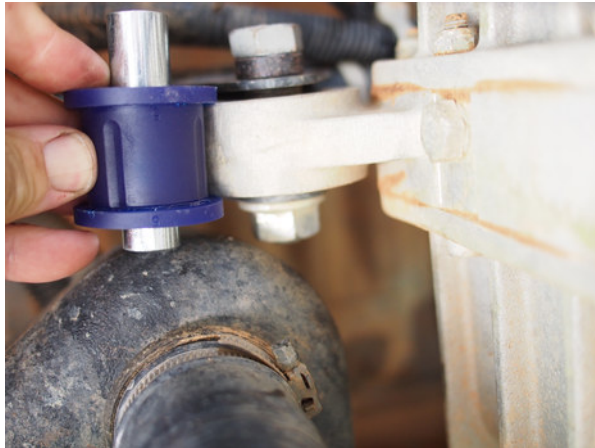
one full poly-bush with cut off flange

SuperPro SPF0108, or SPF0109 Jeep rear spring eye polyurethane bushing is the correct diameter to fit inside the external steel sleeve of the existing silentblock, either use another flange cut off one end of a second bush, or two short bushes to complete the job.

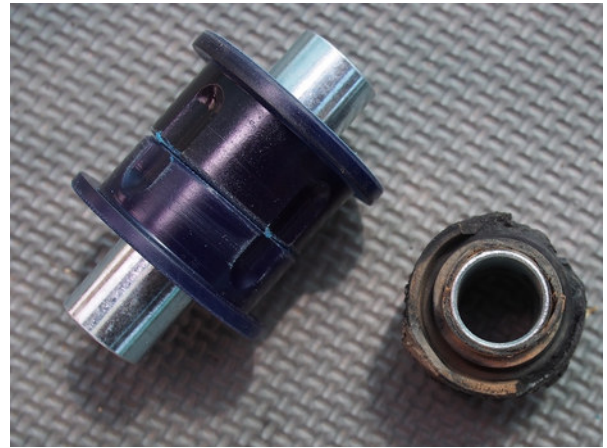
cut in half for insertion from each side

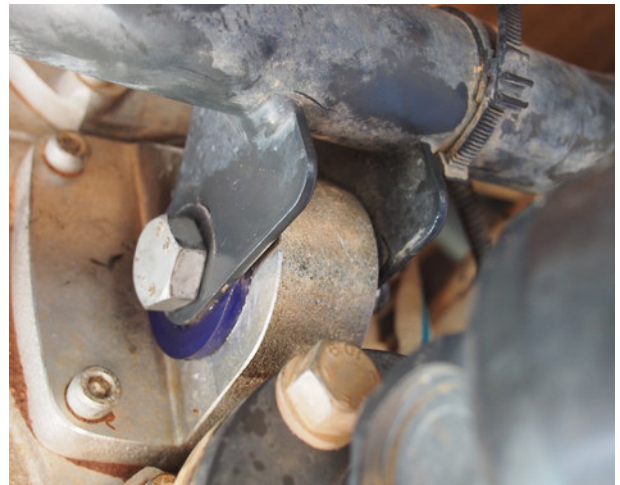
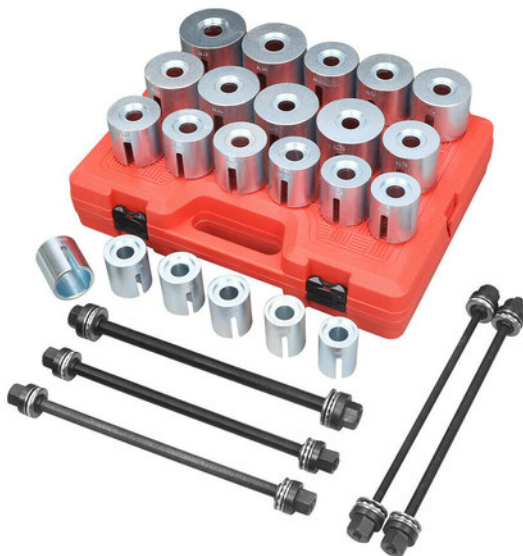
The image at right shows the poly bush installed in the transfer case rear mount, this is done in situ. The easiest method is to remove all but the top front transfer case crossmember bolts on each side of the chassis and then rotate the crossmember away from the transfer case.

Using a "Universal Pull Press Sleeve Kit Bearings Seal Removal Bushing Driver Set" to remove the remains of the old silentblock rubber, and also to 'press' the replacement bushing into position using supplied lubrication grease. The flanges locate the bush as it's not bonded to the crush tube and eliminates the possibility of metal to metal contact between the transfer case flange with the chassis mounting brackets.

Repair eliminates vibration and drive line shudder; also noticed a significant reduction in transmission slop and clunking. Inspection 15,000km later shows the poly bush repair to be in perfect, as-fitted, condition. LandCruiser; spring eye rubber bushing can also be made to fit, Toyota Part 9038518021.

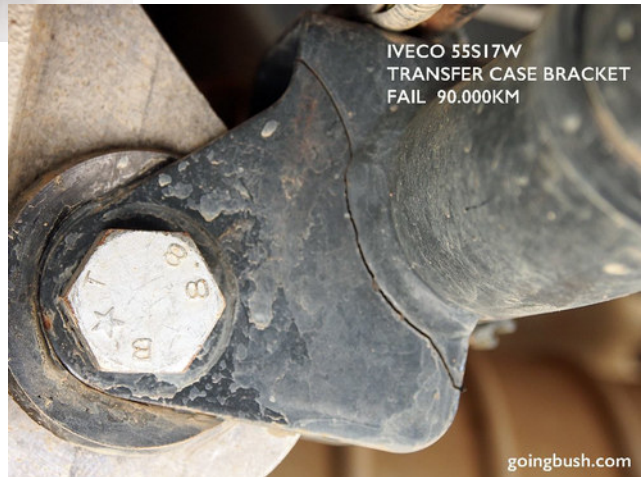
If left unattended worn bushes can result in upper brackets cracking and breaking free from the mounting cross bar along the welds. (right)

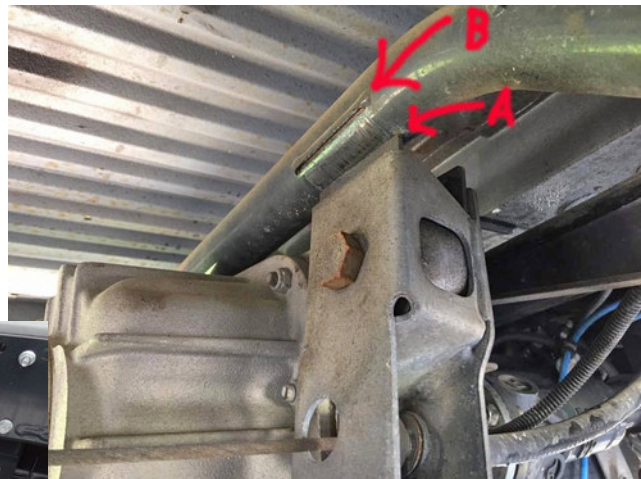
The upper mount has been redesigned on Euro-6 (left) & is unlikely to break away from cross bar).

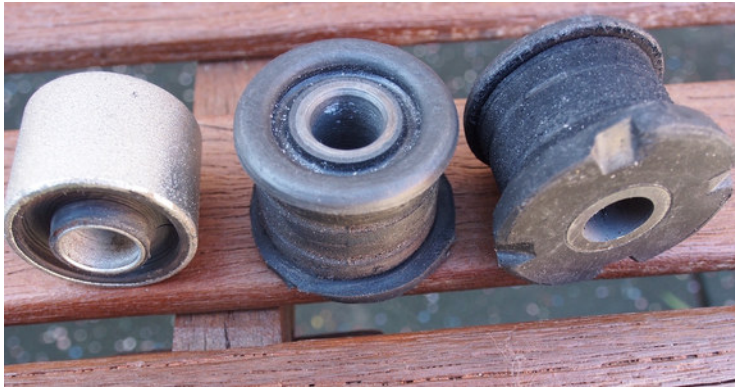
Modified Commodore strut rod bushes (Kelpro 28006) are the most successful retrofit bush in use to this date, and seem to be a 'fit & forget' solution. Modified on a Lathe the crush tube needs to be shortened and rubber profile adjusted. They are pressed into the bare alloy of the Iveco mount without the steel 'outer' ring of these Iveco bush. These are fitted into all three positions on the Iveco transfer case with no issues to date.

Images show unmodified Commodore bushing alongside modified bushing installed into factory rear mounting bracket. (makes no difference which way around it is inserted.) Generous use of rubber grease helps with the installation.

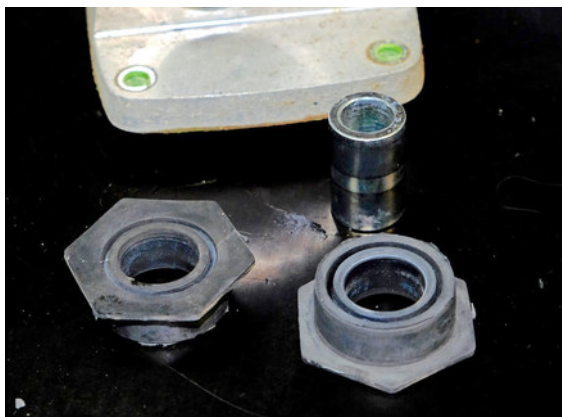
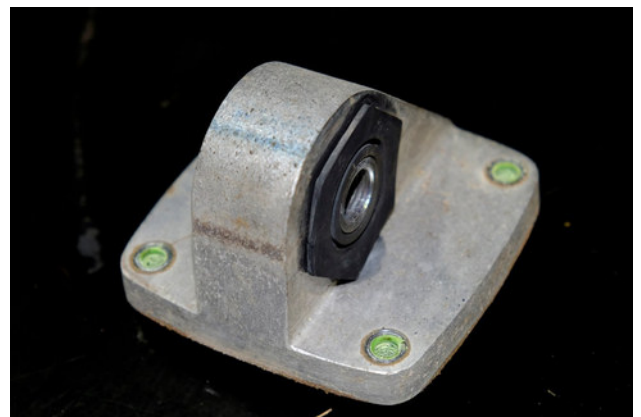
Its only taken 7 years since the vehicle was introduced into Australia, Iveco have finally produced a redesigned transfer case mounting bush, shown below. Easy to install, hopefully it proves reliable in service.

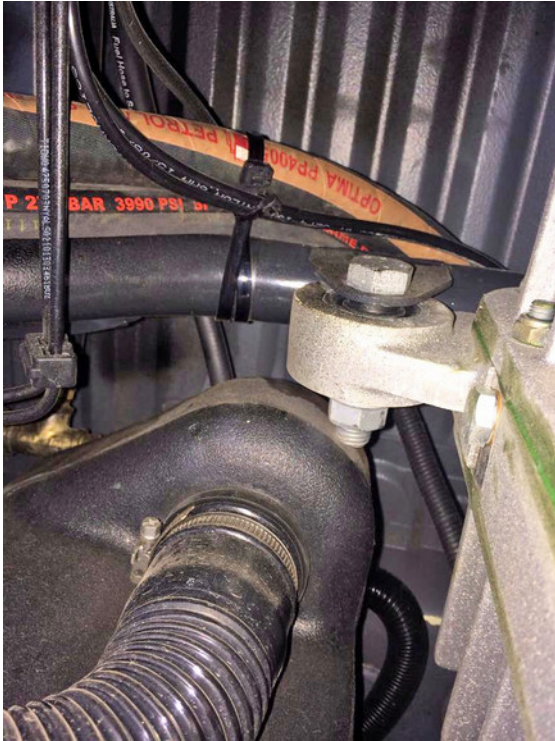
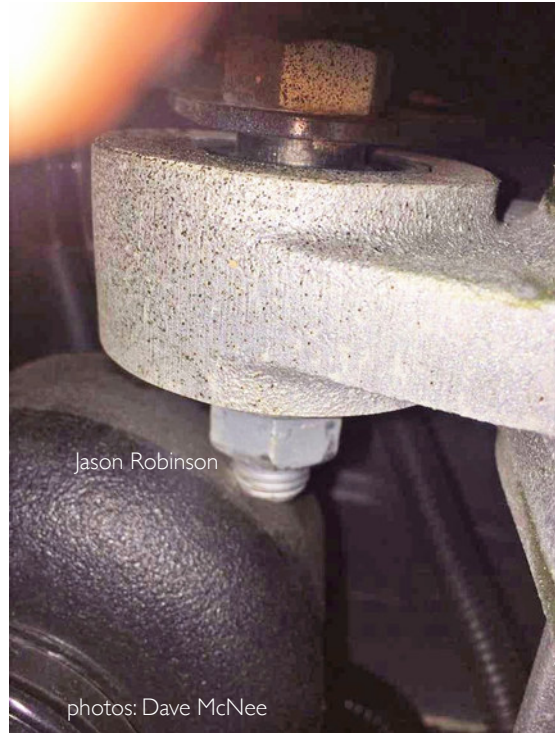
Transfer Case bolt - Fuel Tank interference

Whilst under your truck looking at the transfer case be sure to check out the top left transfer case mounting bolt. Something else that got past Quality Control in Italy, and Pre Delivery Inspection at your dealer is the bolt protrusion rubbing into the fuel tank.

If left unchecked is likely to wear a hole right into the tank. This will be a warranty repair but you need to point it out to the service centre, it is not something they will notice, and is not on the service schedule.

One DIY fix is to add a 7-8 mm spacer behind the bolt head, shown in the image at left, thus pulling the exposed bolt end back away from the tank.

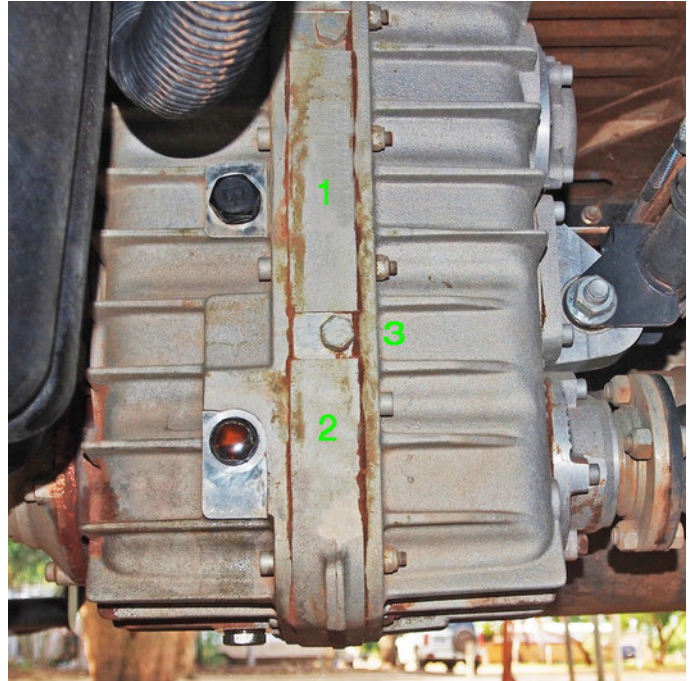
Adding exactly 3.0 L of oil brings the level to the top of the sight glass !!

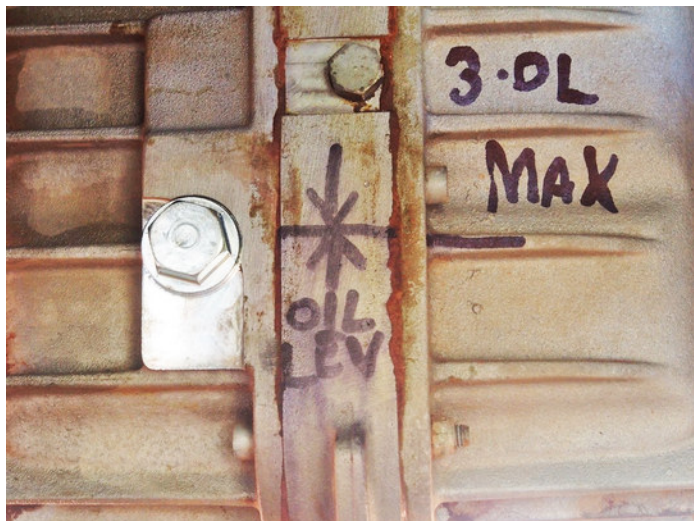
Transfer Case Filler plug and sight glass be should be retrofitted with metal M20x1.5mm sump plugs.

Some transfer cases have been damaged by over filling prior to delivery to the customer and were replaced under warranty. The plastic plug and sight glass are prone to loosening, over tightening results in breakage. It is prudent to replace each with metal M20x1.5 bungs or easily obtainable sump plugs.

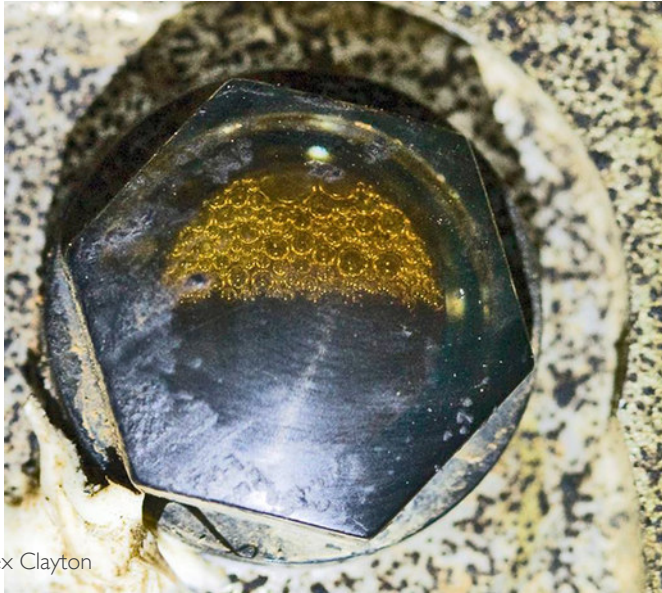
Perhaps, because of its mixmaster design, but for whatever reason the Transfer Case oil suffers from foaming, Foaming leads to overheating. Overheating leads to mechanical failure.

oil foaming in sight glass

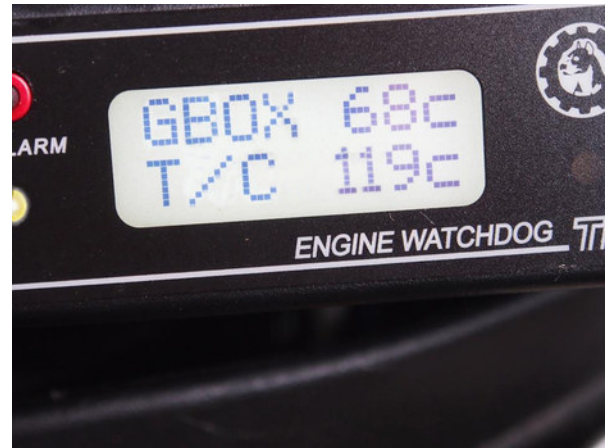
Overwhelming results show that the TC temperature slowly climbs to about 90°C during the first hour of towing at speeds above 90kmh, then after reaching 90°C the TC temp rapidly rises to above 125°C.

It has only taken 2 Years but finally Iveco Service Centres in Australia now acknowledge the Transfer case has "issues" and Iveco is "working on a solution". Iveco are at least fitting Temperature sensitive Labels on Transfer Cases, possibly as a study to determine the cause of the TC failures in Australia

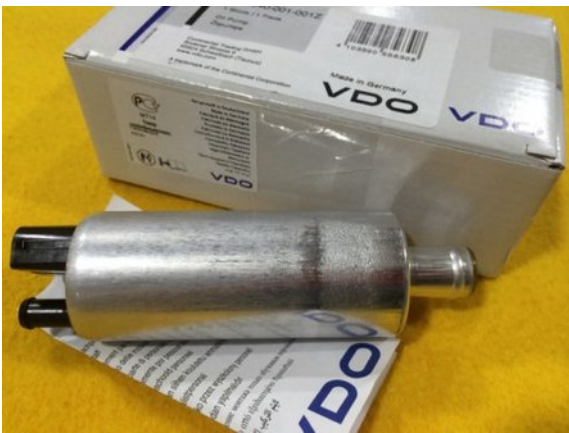
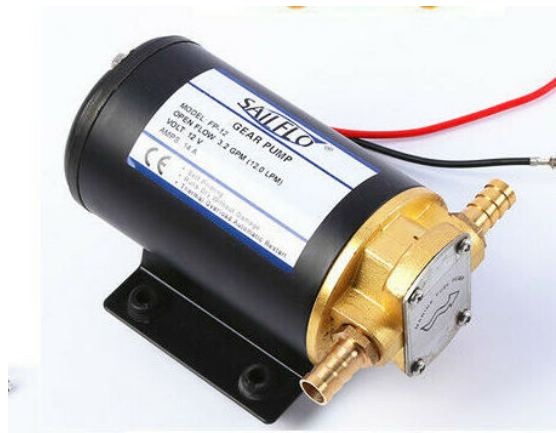
The 55S17W Transfer case does contain an internal oil pump to supply lubricant to the upper shaft and low range planet gears, but unfortunately there is no external oil pump port, so an external 12v oil pump is needed. Aftermarket turbo scavenge gear pumps are ideal for our application.

Gear type oil pumps are self priming and will only flow oil when the pump is running, there is no convection flow nor any oil drain-back issue. To install the pump, suitable oil pick up and return lines must be plumbed in to the transfer case. This can be done using M20x1.5 banjo connectors in the TC drain and Filler holes, or by drilling and tapping the Transfer Case in suitable locations .

For the 1/2" pick up line the safest place to drill and tap the transfer case is at the bottom of the thick alloy casting below the sight glass hole (sight glass replaced by M20x1.5 Sump Plug in above image).

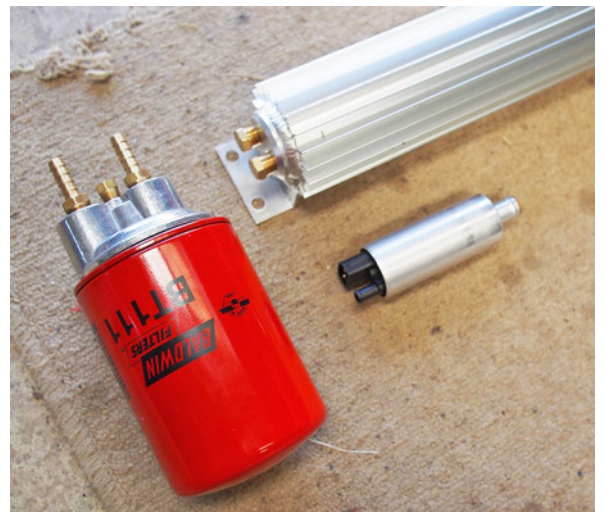
The cooler is a 18" Finned Alloy Dual Pass transmission cooler, but many types of automotive oil cooler can be adapted to this task.

Use rated auto transmission hoses or oil transfer hoses only. Don't be tempted to remove the gauze filter from the VDO pump inlet, it will void the Pump warranty. The 1/2" hose from pickup on TC to Pump inlet may need reaming out, as its a very tight fit on the pump.

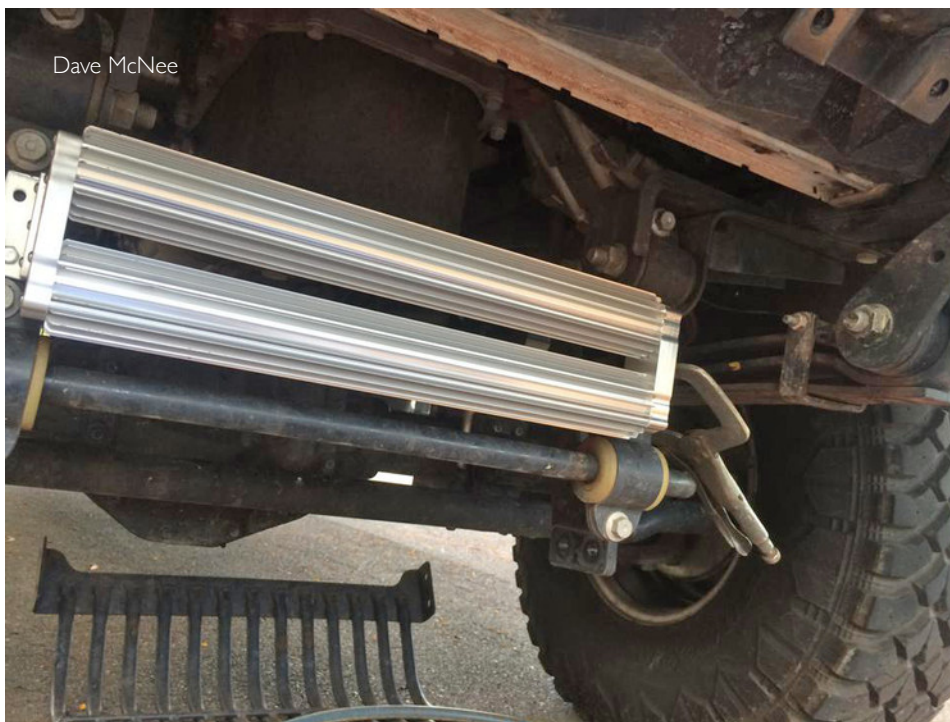
NOTE: the VDO Oil pumps have been failing in service, Cheaper "Geared Turbo Scavenge pump" from eBay are more bulky and noisy but have been much more reliable.

Once installed fill transfer case with total oil volume, run pump using manual over-ride switch to fill hoses, cooler and filter, otherwise you will be driving with ~4.5L in Transfer Case, which in itself can cause problems. Either use previously described method to determine system volume for correct oil level, or else park truck with two left wheels 250mm higher than right wheels and use bottom of sight glass hole as a level.
