COMPLEAT IDIOT'S GUIDE TO IVECO DAILY 4X4 55S17W

2020 REVISION

About this Book

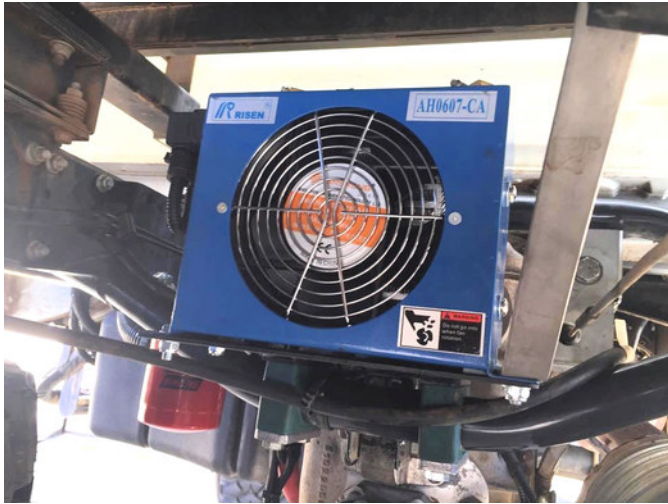
Image at left shows TravelTrucks professional transfer case cooler installation

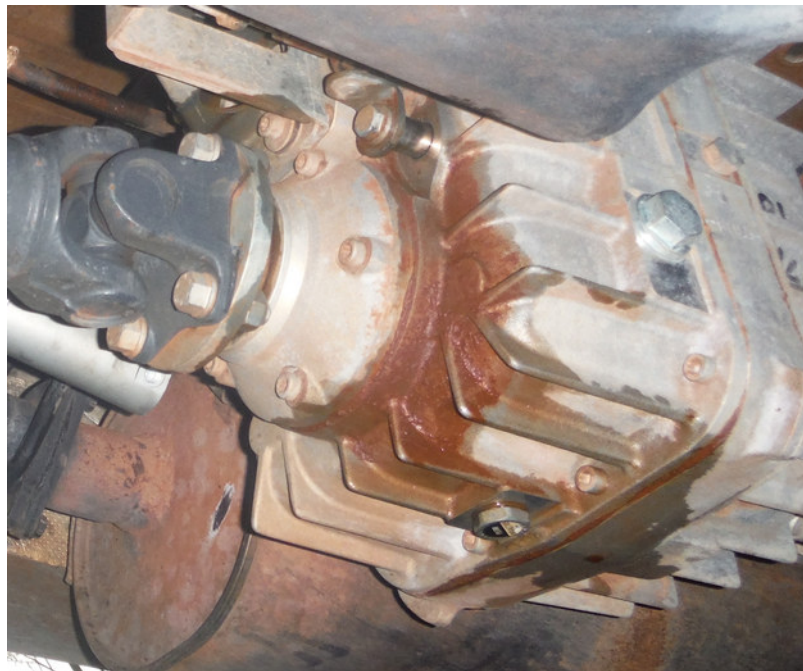
telltale seal leak- oil sling pattern on surrounding parts

no comment needed !!

Apart from a visual inspection a burning oil smell is a foreboding sign, the oil slings in a circular pattern around the seal, some settling on the exhaust pipe to produce the oil burning smell. Always determine the source of oil smells.

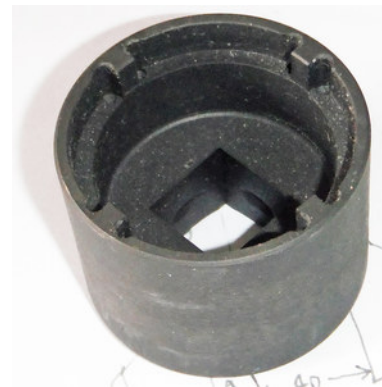
TC nut tool Iveco part no 99355047

The Transfer case input / output seals can not be serviced without the special keyway socket needed to undo the flange 'ring nuts', tool part no. 99355047. Most service centers have never seen one of these vehicles let alone have the tools required. It is prudent to buy your own socket, and even carry spare seals. In the event you do require seal replacement is a remote location at least you will not be stranded waiting for tools and parts.

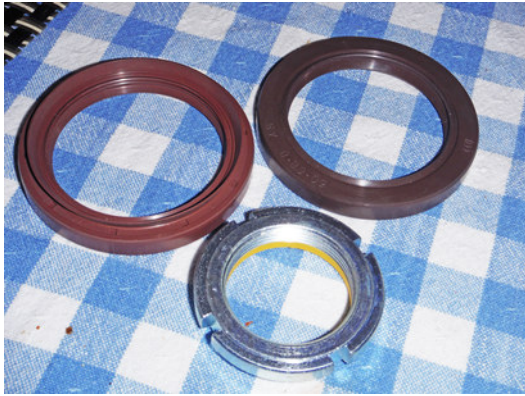
Genuine TC output seal 42559750 is \$67 from Iveco.

Equivalent 68 x 50 x 8mm Viton seal part no 103143V from bearing supply \$27.00 handy to keep as a spare .

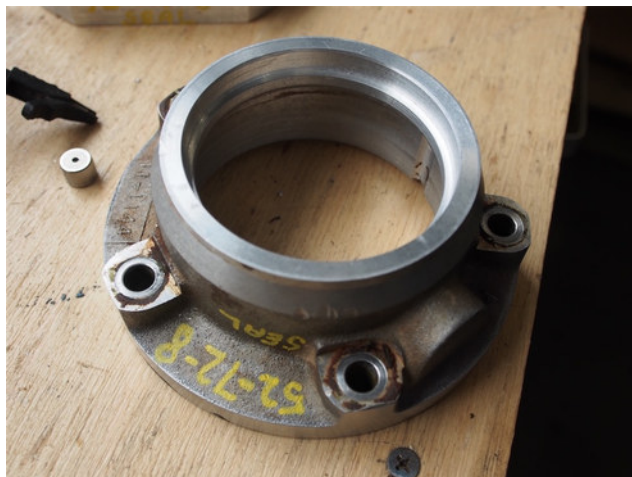
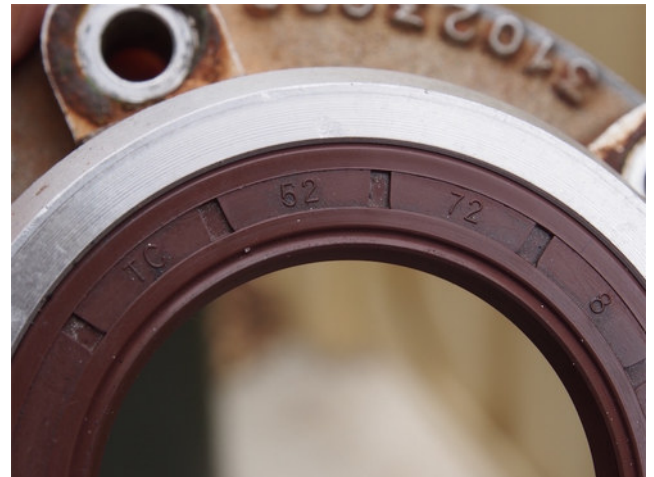
As can be seen in the image at right the oil seal needs to be pressed into the internal surface of the input shaft bearing housing, This means removal of the housing and disturbing the bearing. It makes no engineering sense.

The housing can easily be modified on a lathe to accept an oil seal with the same internal diameter but a larger external diameter (72x52x8mm instead of the original 68x52x8). Future seal changes only need the drive flange removed to replace the seal.

A popular modification is to 'externalise' the oil seals. For some unknown reason the Input (and output) housing seals are on the inside of the housings, instead of the outside. Mind boggling engineering requires removal of housing to replace a simple seal.

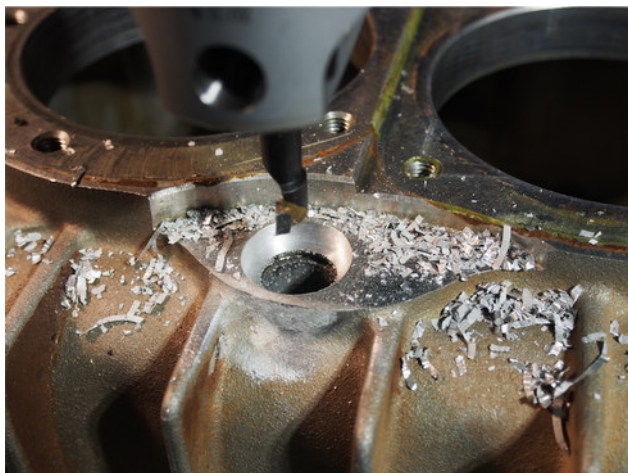
Boring out case to accept external seal

It is a waste of time and effort to re-install the o-rings, have your Transfer Case front cover milled out to accept a pair of rotary seals, which last infinitely longer and can subsequently be replaced from outside without disassembly.

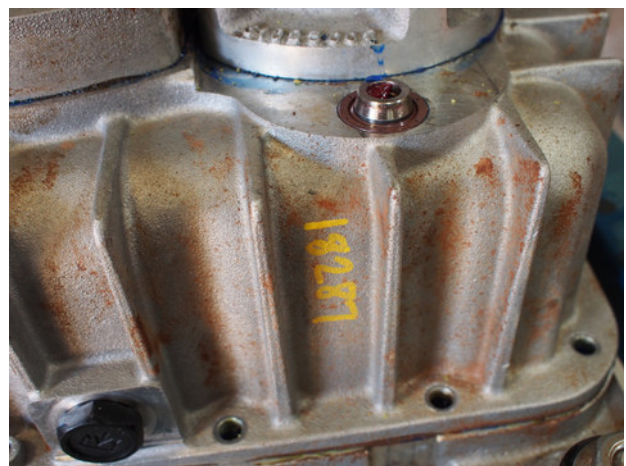
External oil seal in place of selector shaft o-ring

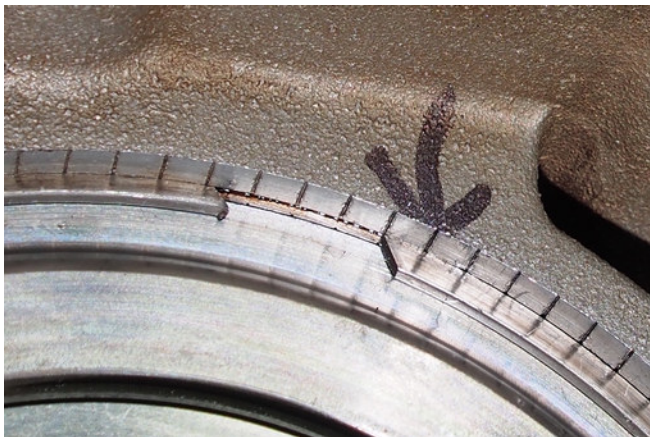
less than 0.9mm of circlip sits in the groove

The problem is with quality control (or lack of) during the Transfer Case manufacture, the circlip groove machining is inconsistent, some circlips have been found to be loose, others are tight in the groove, regardless of age or distance travelled. A simple remedy is to install a clamp device retrofitted into the Transfer Case rear cover to keep the circlip expanded into the groove so that it is impossible to fail.

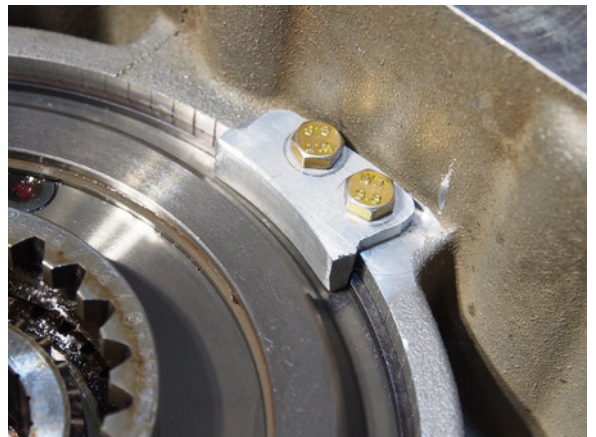
Circlip 'lock' makes sure it can never pop out

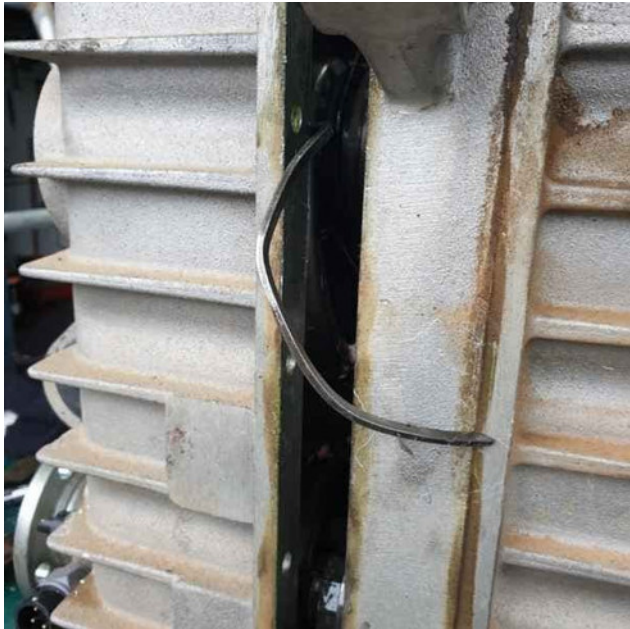
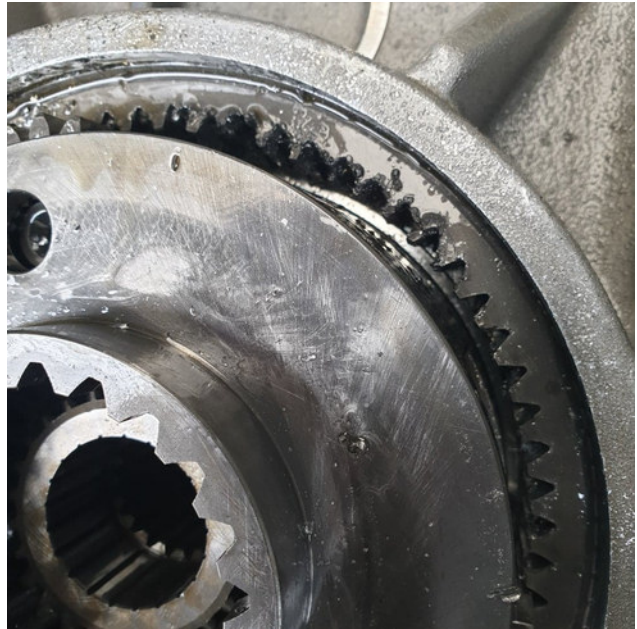
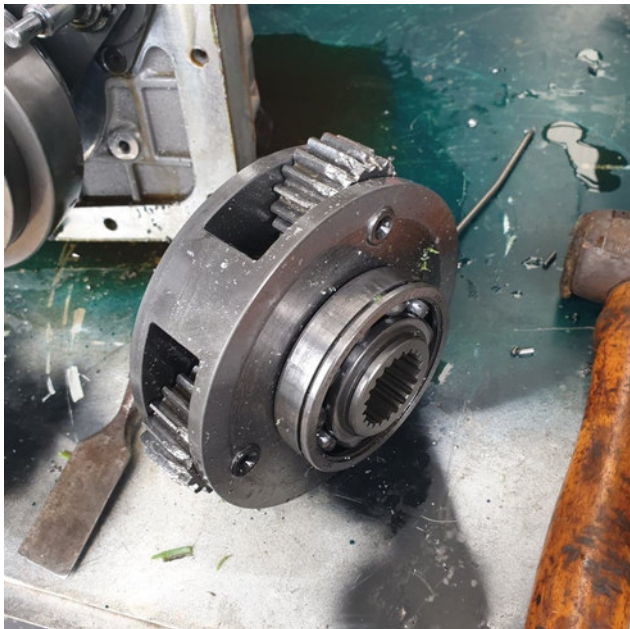
Classic Low Range circlip failure . The stuff nightmares are made of.
20,000km , never been off-road, only once been in LowRange ,

Once the circlip fails the damage is catastrophic, other than replacing the entire Transfer Case remote or field repair is impossible.

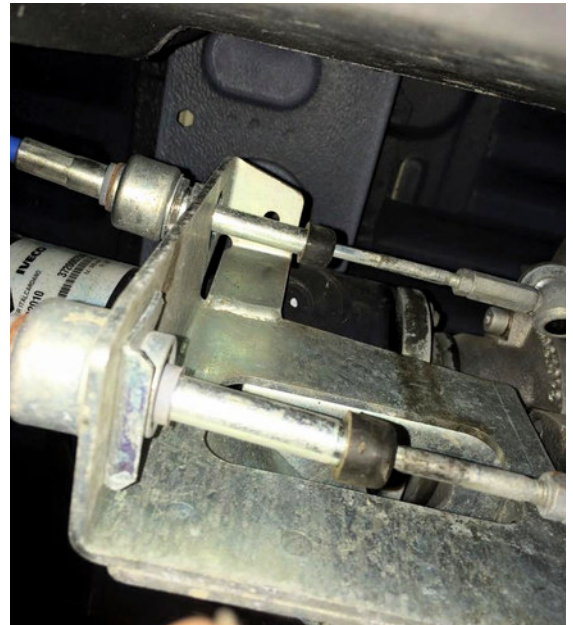
It is an inconvenience rather than a disaster, and noted by the respective transfer case gear moving freely without the ability to change back into high gear.. The Bowden Cable Clip is a U shaped clip engaged into a recess in the end of the Bowden Cable.

It would have been sensible to rotate the clips at manufacture so that they are not gravity assisted when they come loose. Brake Hose clips of appropriate size may be substituted as a field repair:

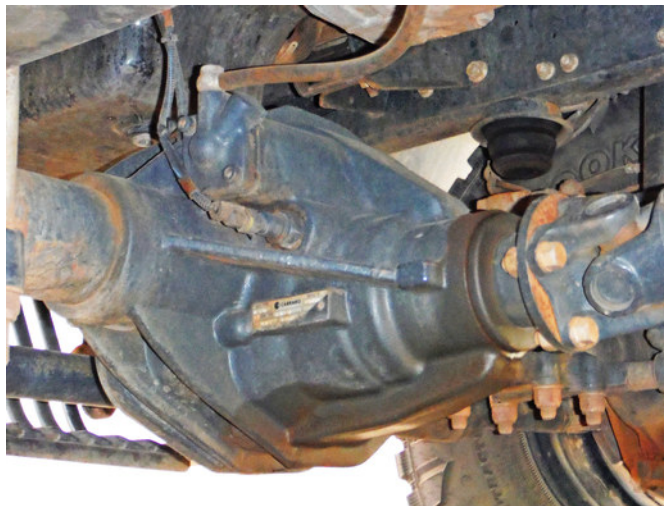
ARB diff breather extension kit

The Breather problem may be partly to blame for a more serious issue, Leaking Pinion Seals. (as can be seen in photo of front diff above)

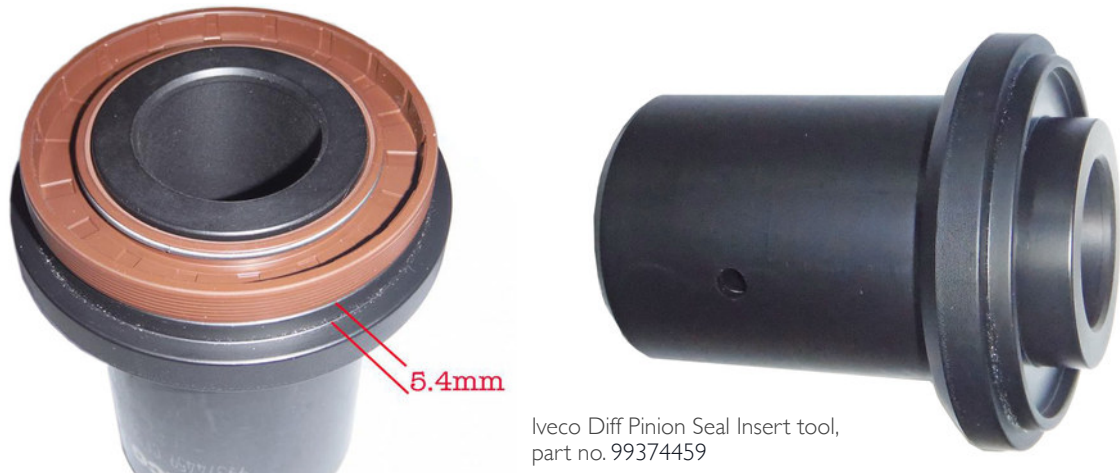
Iveco Diff Pinion Seal Insert tool, part no. 99374459

In some cases the Diff pinion seal starts leaking after only a few thousand km, it is a warranty repair. Oil leaks are a roadworthiness issue. It also has been noted that some seals replaced under warranty have started leaking almost immediately. A special tool, Iveco Part no. 99374459 is needed to set the seal position in the diff housing 5.4mm below the diff nose.

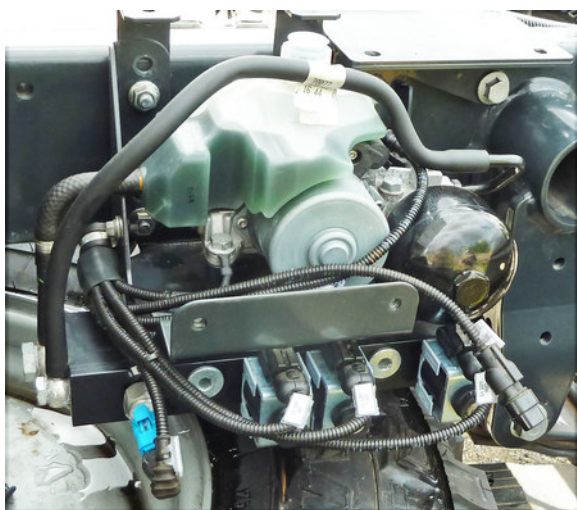
APU, Diff Lock Hydraulic Pump

The check light on the Diff Lock control panel is not mentioned in the owners handbook, Iveco service centres often misdiagnose a check light error. The check light relates to the Fluid reservoir in the Auxiliary Power Unit, aka. Hydraulic diff lock pump, under the metal cover above the spare wheel. If you have low or leaking hydraulic fluid the light will flash or remain on.

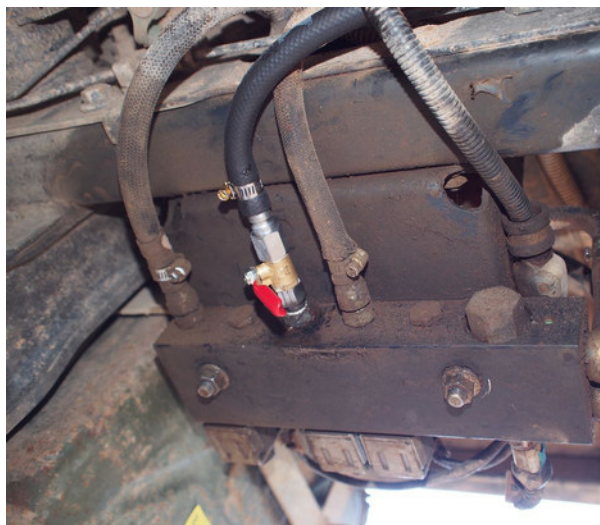
Tap added to CDL line to "fix" leak into transfer case

If you need to add fluid and don't have an obvious leak then the fluid is leaking into one of the diffs or more likely into the transfer case via a worn centre diff actuator seal. To be sure check the diff and transfer case levels. The "Hydraulic oil" is a Synthetic fluid known as "Tutela GI/R" almost unobtainable in Australia, do not add regular power steering fluid or hydraulic fluid, Penrite "LDAS" is a locally obtainable equivalent.

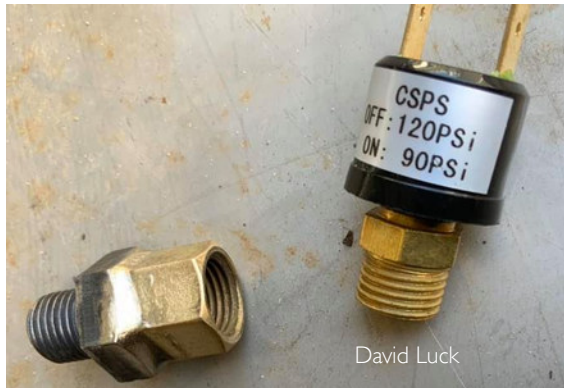
The APU pressure sensor is a known fail point, (check light fault) \$380 from Iveco.

It can be substituted with any of a number of suitable "on-off" air pressure sensors switches which are found between \$10 and \$50 . With a suitable metric to NPT adaptor an air compressor switch works just fine .

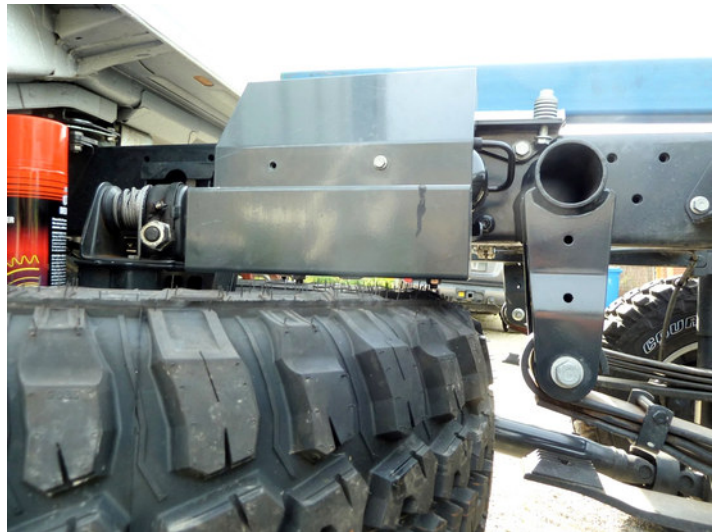
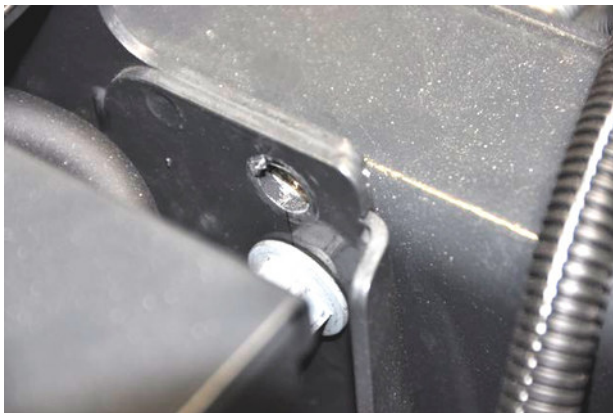
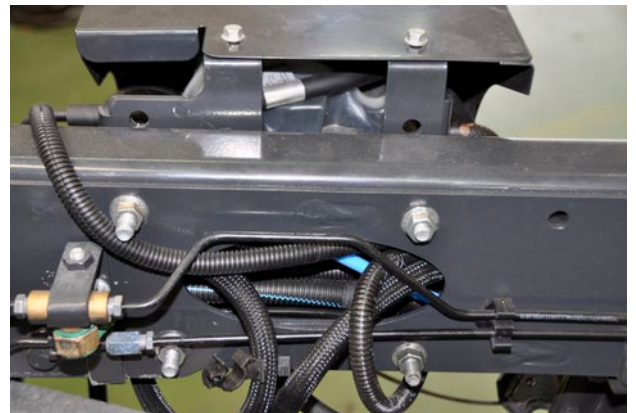
When larger tyres are used on the existing spare wheel carrier the tyre sidewall is forced up against the APU. Any pressure on the valve body will cause the Diff Locks to not operate correctly. The APU must be raised or relocated to give adequate clearance. Remounting the APU 20mm higher resolves any issues.

Remove the unit from the chassis and drill 4 new holes in the backing plate. Each new hole will be 20mm below the original hole. Re-bolt to the chassis rail using the original bolt

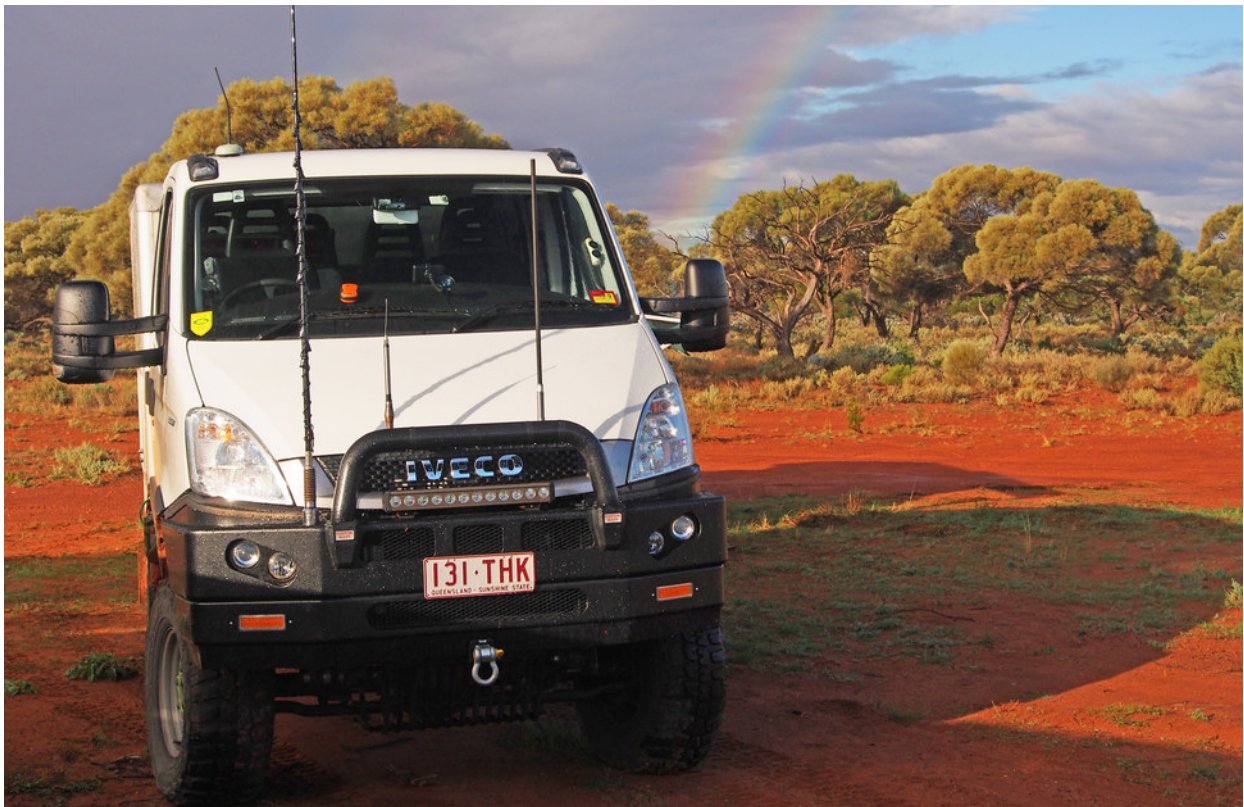
The Iveco Lean is caused by uneven thickness spring spacers.

Not only are there the wedged spacers on the rear spring perches, but there are also flat spacers under the front spring packs.

Both the left spacers are higher than the right. This is not to adjust for road camber as LHD models and RHD models use the same spacers and both lean to the right.

Apparently it is to compensate for the weight of the Fuel Tank, Spare Wheel and driver on the left side of LHD models. Too much trouble to change for RHD models ?? They are bolted to the axle housing with 4 Allen head bolts . . You will also notice your "u" bolts are different lengths.

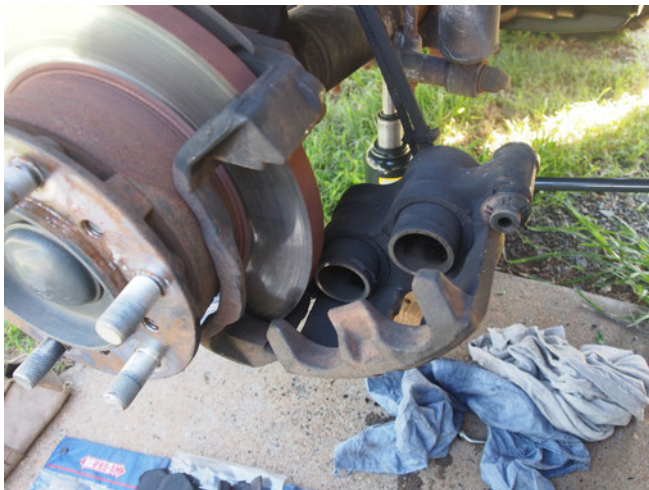
DIY pad change at 45,000km

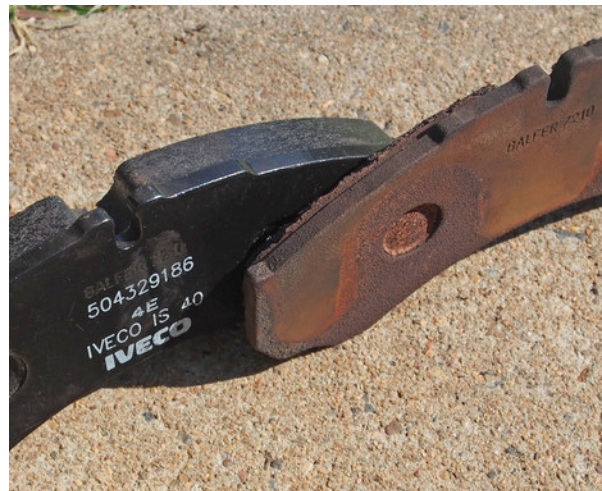
new vs pad passed as serviceable by dealer

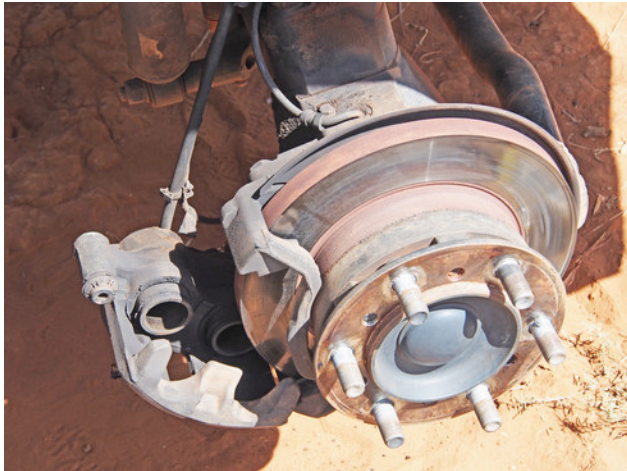
same truck, 60,000km , clearly needs a rotor grind

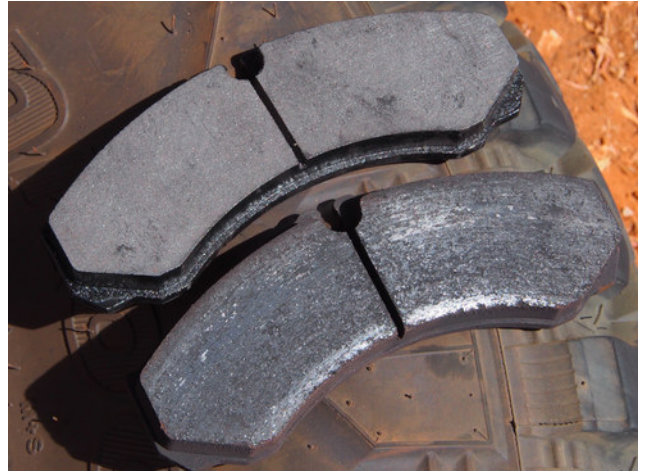
new softer LPR pad vs 15,000km IVECO "metallic pad"

The genuine front pads appear to be too hard, and have sintered metal embedded in the compound, they eat away at the rotor which is not that good because the rotor is so bloody expensive to replace. Aftermarket pads appear to be softer and will wear out faster but give a better brake performance and less wear to the rotor but more likely to fade when overheated.

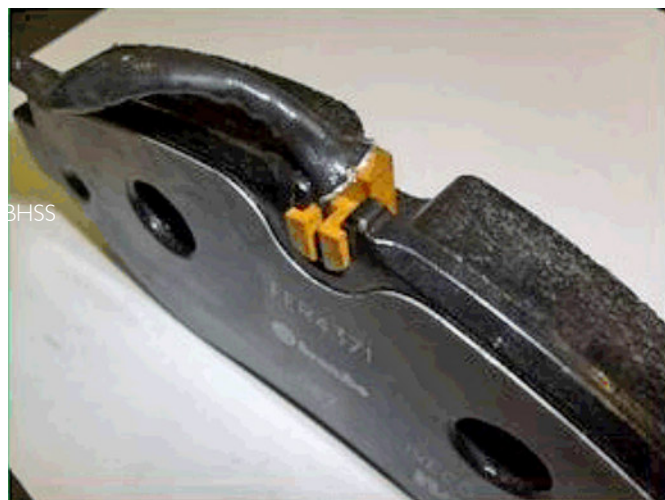
Always fit new wear sensors with new pads, the correct orientation of wear sensor is shown above, with the "feet" of the sensor to the outside of the pad.

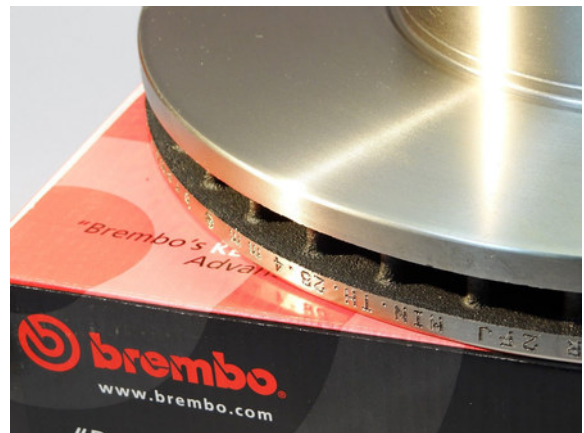
bread and butter BA Falcon Ute rotor

BA Falcon Ute, tare 1700kg gvm 2700kg
 297mm x 28mm Vented Rotors,
 Iveco 55S17W tare 2800kg gvm 5500kg
 297 mm x 22mm NON Vented rotors

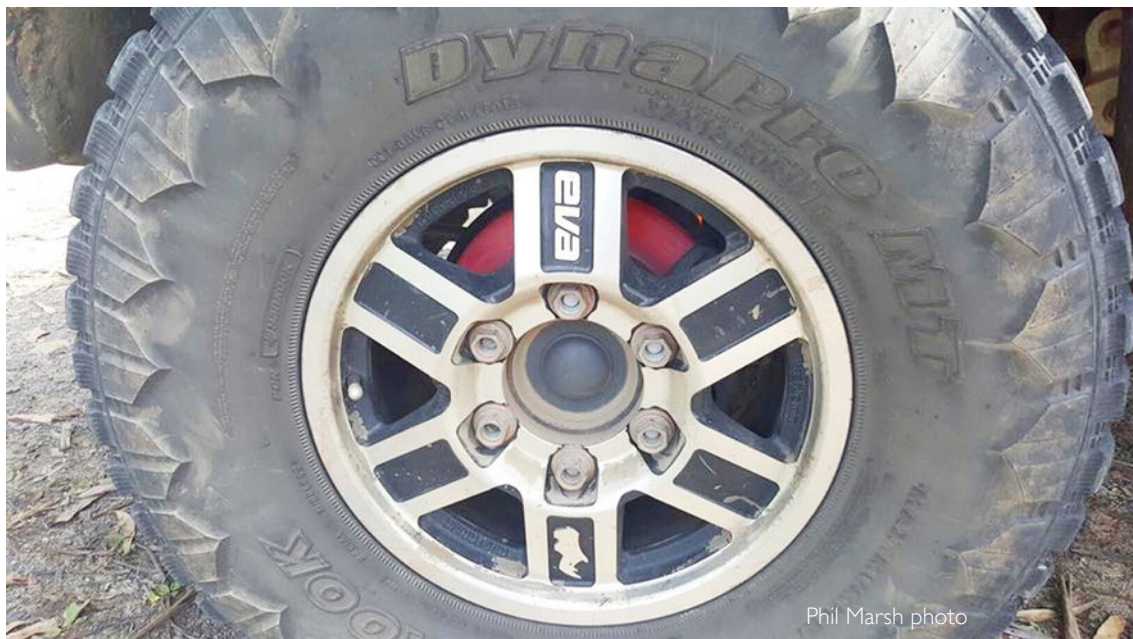
After a Brake Overheat Event - Loose Wheel Nuts

When your 55S17W front brakes overheat, and they WILL, not only because the front brake rotors are an inadequate size, and non-ventilated, but also because the rear brakes are inefficient, you will immediately need to retighten the front wheel nuts.

The powder coating or paint under the wheel nuts softens or melts, and the wheel nuts will lose their tension and most likely come loose.

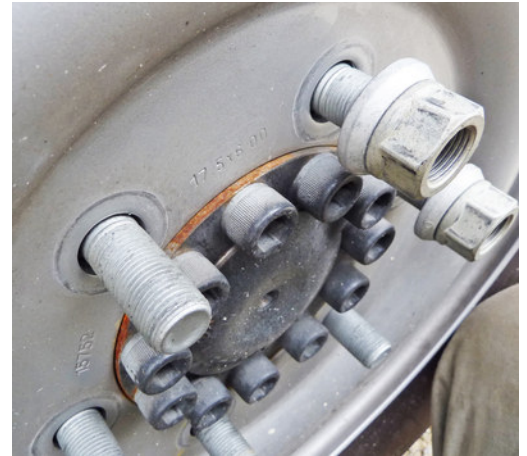
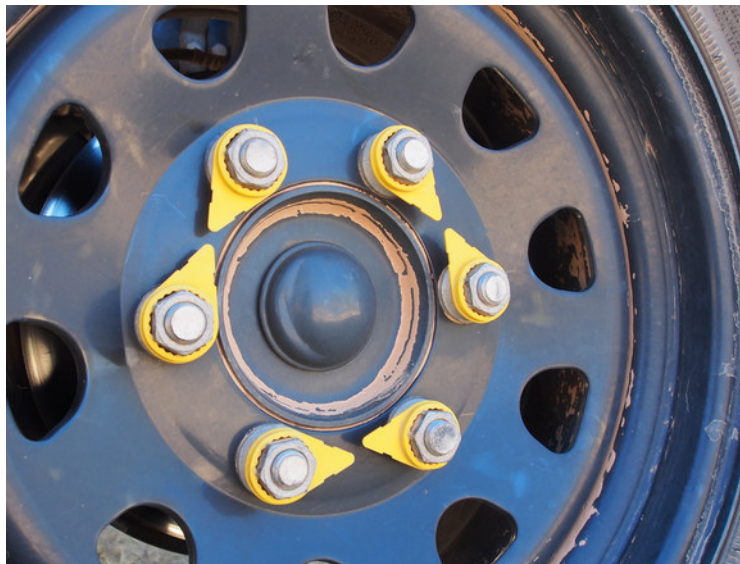
On these vehicles the use of wheel nut indicators is highly recommended, Visual inspection will show immediately if a wheel nut or nuts are loosening. Available in common sizes from Safety suppliers or Truck equipment suppliers, but you guessed it, the Iveco 27mm nut size is not common. Obtainable from Iveco aftermarket specialists or look online for "27mm CheckPoint Nut Indicator"

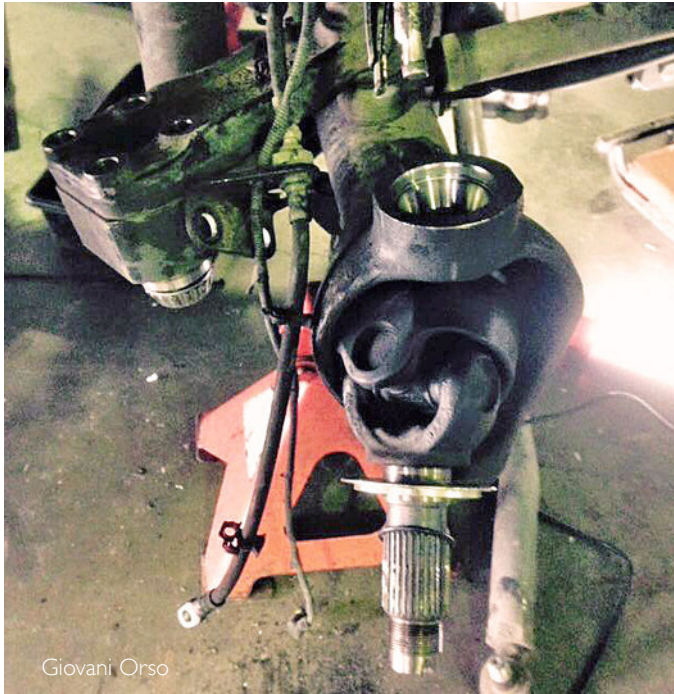
Shown at left, is the, right side front axle of the 55S17W with the Swivel Housing removed, This is the level of disassembly that is required just for a basic brake rotor replacement each 80-100,000km.

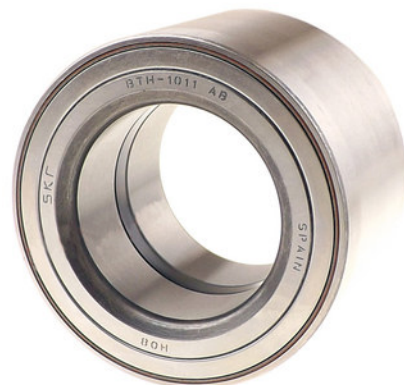
OEM is SKF BTH 1011 AB, 55x90x60mm

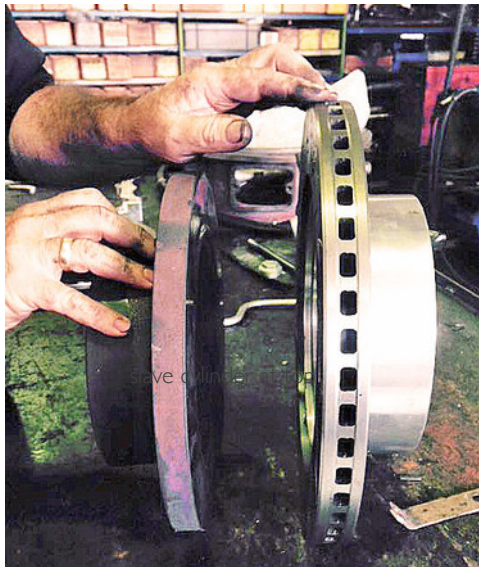
Inside swivel housing, shown at right with BHSS engineered CNC caliper adaptor

Vari Race Brakes have designed a CNC machined caliper adaptor to use the original caliper which has sufficient clamping force for the larger diameter rotor, there is a significant increase in mechanical advantage.

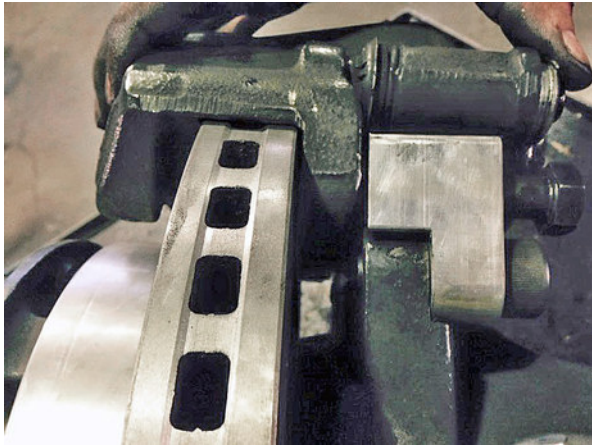
love it when a plan comes together !

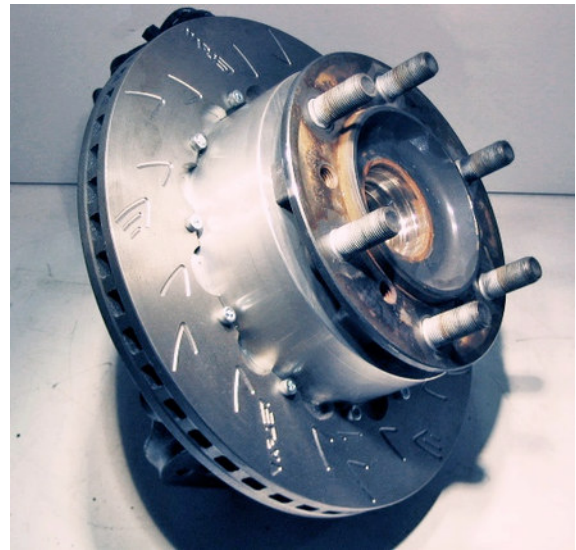
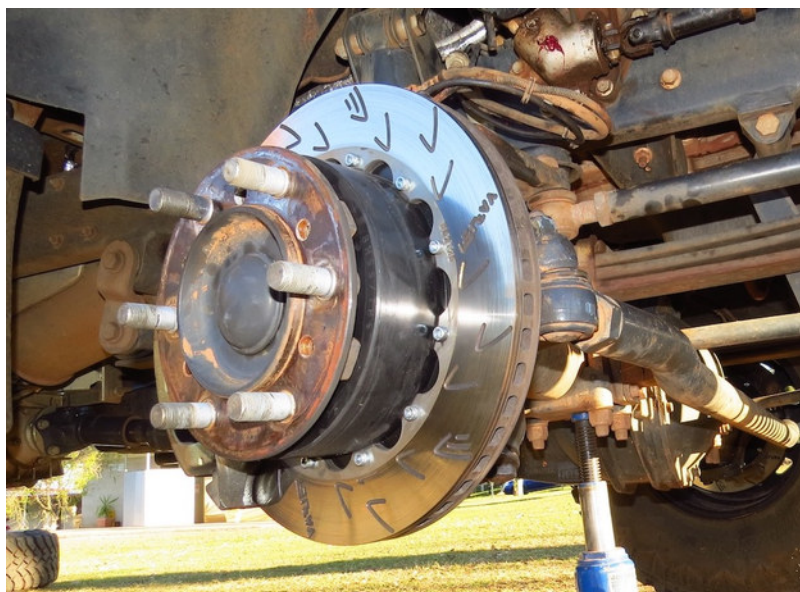
Key	Iveco Desc	Name	Iveco pn	Alt Part
1	Cover	Hub Cap	42558748	
2	Fastening Ring	Axle Nut	42558749	
3	Ring	Washer	42558750	
4	Wheel Hub	Hub	42558754	
5	Screw	Wheel Stud	42558755	
6	Brake Disc	Rotor	2558752	
6A		Flat Rotor		BHSS
6B		Rotor Hat		BHSS
6C		Rotor screws x12		BHSS
7	Half Ring		2558756	
8	Screw	Rotor bolt	2558755	
9	Support	ABS Drum	42558763	
10	Screw	ABS bolt	42558751	M6x16
11	Shim		42558758	
12	Wheel Bearing		42558516	SKF BTH 1011AB
13	Fastening Ring	Circlip	42558518	
14	O-Ring		42562627	
15	Washer		42558760	
16	Dust Cap	Backing Plate	42558762	
17	Screw	Bolt	42558761	
18	Brake Caliper Assy		42558806L 807R	
18A	Brake Pad Set		2996465	
18B		Brake Pads		EBC, DP14942
19	Ball End Pin	Swivel Pin	42558688	
20	Screw	Bolt	42558689	M14x30
21	Lube Fitting	Grease Nipple	42558679	
22	Lever	Steering Arm	42562619	
23	Shim		42558683/4/5	.1 .2 .35mm
24	Bearing Housing	Swivel Housing	42558686R...687L	
25	Ring	Wiper Seal	42558666	50x65x5

26	Diff Bearing	Swivel Bearing	42558667	SKF 32205 BJ2
27		Caliper Spacer		BHSS
28		Spacer Bolt		BHSS

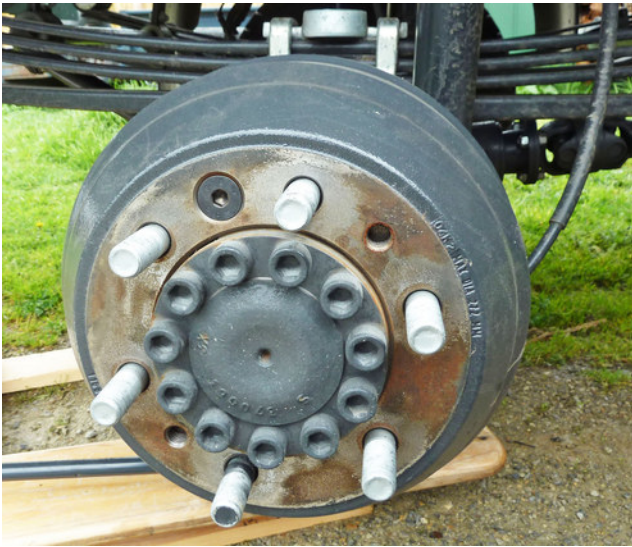
The Iveco Daily 4x4 55S17W has rear drum brakes, Even the new re-bodied Euro6 model still has the same rear Drum Brakes.

The hydraulic drum brakes are single leading shoe 270mm x 80mm with "automatic adjusters" (they don't work).

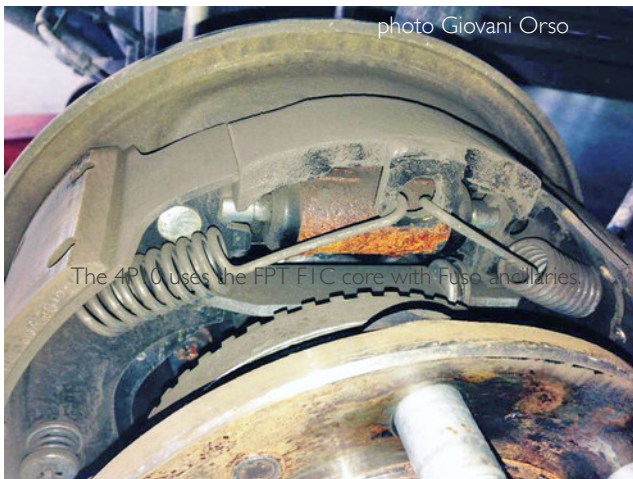
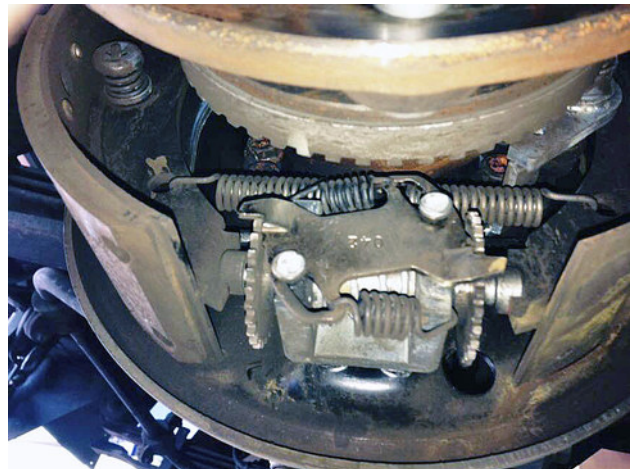
The rear brakes can be inspected for wear through inspection ports, under rubber covers on the rear backing plates. There are 2 covers on each backing plate so that the wear indicator on each shoe can be inspected.

This is a critical inspection. If the rear brakes are working correctly the shoes will last about 50,000km, in the case of the image above the brakes have done 45,000km with minimal wear, therefore brakes not working, & problem not noticed by trained staff during scheduled servicing.

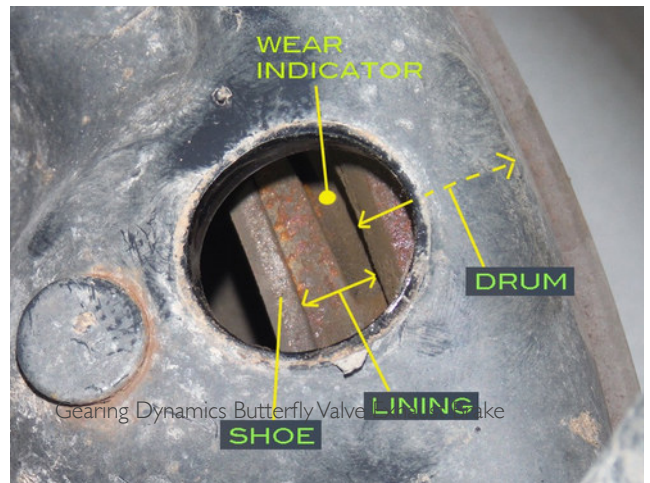
When the linings wear down to the rivets the drums will be seriously damaged and the linings may separate from the shoes. The linings might look like they have much life left but need replacing when they only look to be half worn.

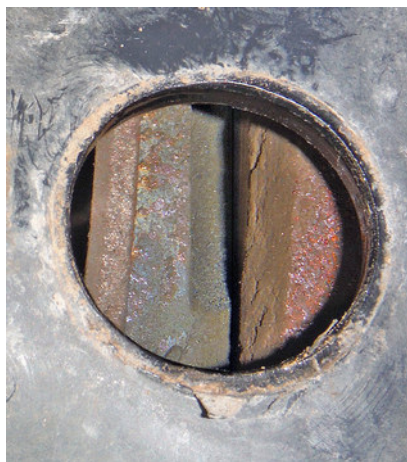
When the Linings are at 30% think about booking in for an independent brake service, there is no electronic brake wear indicator; no dashboard warning as there is for the front disc brakes. Unless you visually inspect the brakes your first warning is going to be a grinding or screeching noise as the rivets start chopping up your expensive brake drums. The yellow rivet is an accurate representation of its depth in the brake lining.

90% Brake Linings

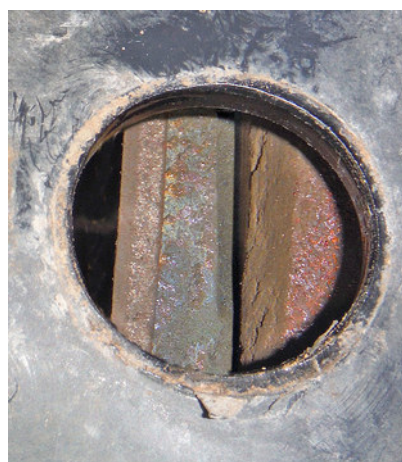
30% Brake Linings

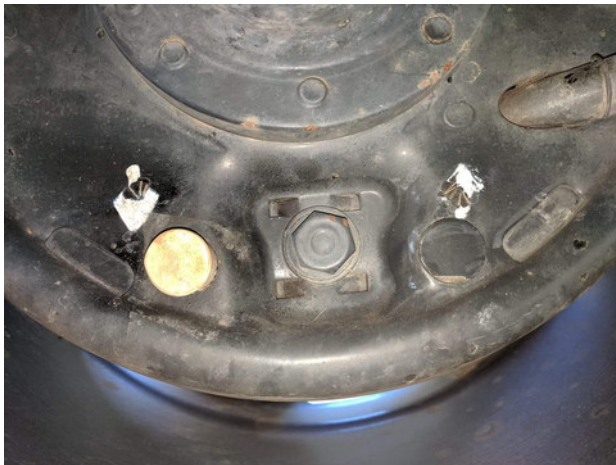
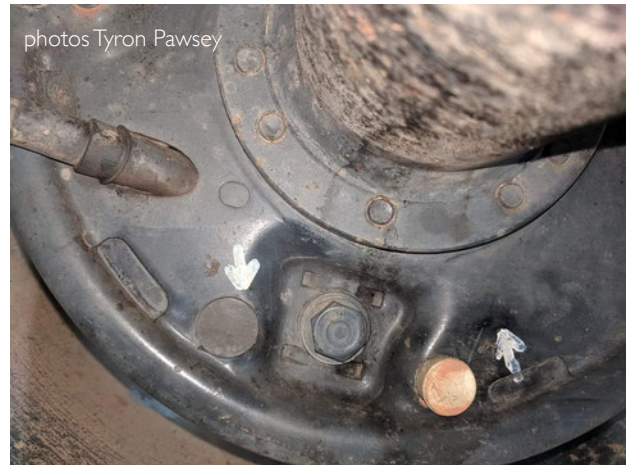
From the factory only the leading shoe is able to be manually adjusted, there is no adjuster hole for the trailing shoe. To be able to adjust the both rear brake shoes a new hole (approx 18mm dia) must be drilled in the backing plate behind the trailing shoe adjuster. Use a suitable rubber bung or cork to cover it

Left side , and right side rear backing plates, note new rear shoe adjuster holes with corks

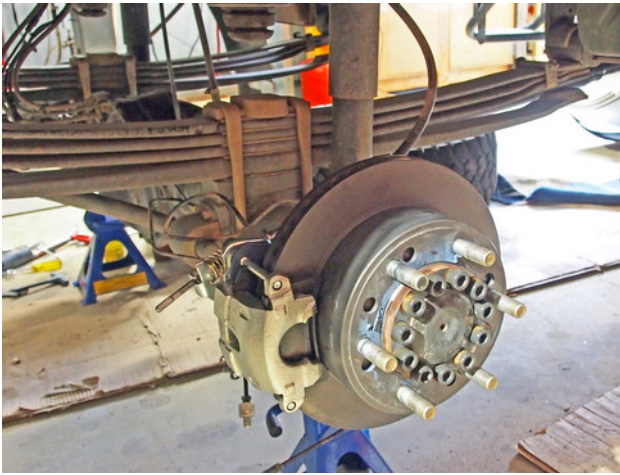
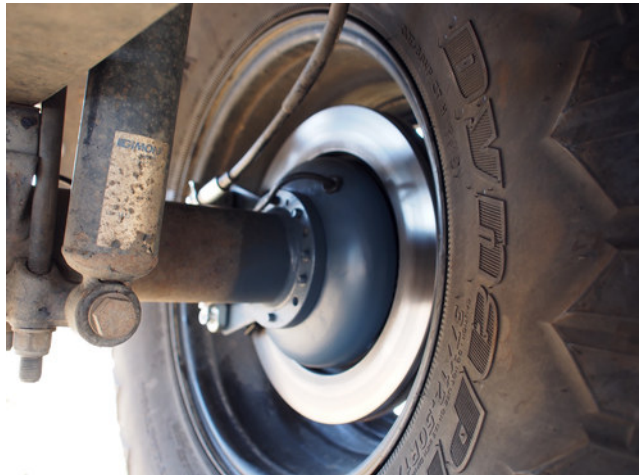
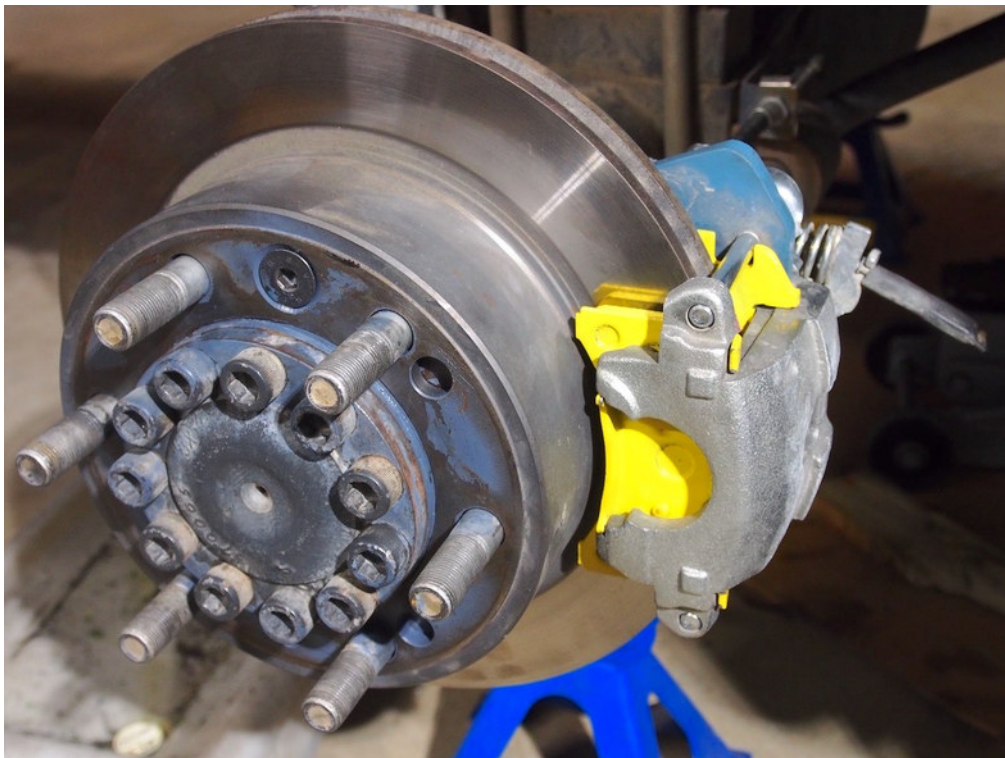
Iveco Australian said it could not be done but here we have a practical and economical vented rear disc brake set up installed on a 2013 model using readily "available" off the shelf parts. The entire cost of parts about half the price of a set of genuine Iveco rear brake shoes. This conversion has been in reliable service for 4 years, no overheating, no fade, no worries.

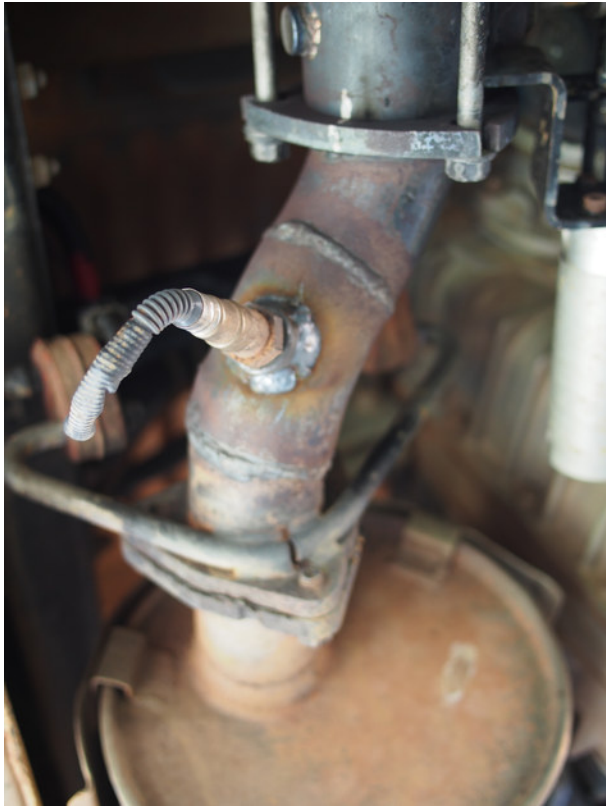
relocated Lambda sensor

Most factory fitted exhaust brakes are mounted on the back of the turbo. Aftermarket exhaust brakes are usually further back in the exhaust pipe, which may cause a few error code issues. The DPF Delta P sensor values will go out of range, this is overcome by fitting 12V pneumatic cutoff valves in the DPF lines. The Lambda sensor also needs to be relocated to behind the Exhaust Brake to stop high Oxygen concentration level fault code during exhaust brake activation.

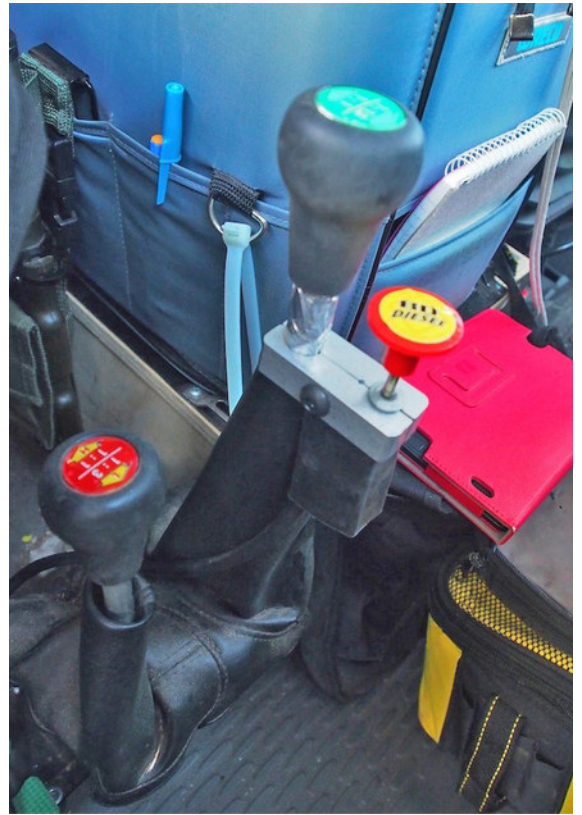
lever mount Exhaust Brake button

The Gearing Dynamics kit includes microswitches for clutch and brake pedals. A relay is wired in to disengage the cruise control when the Exhaust brake is energised.

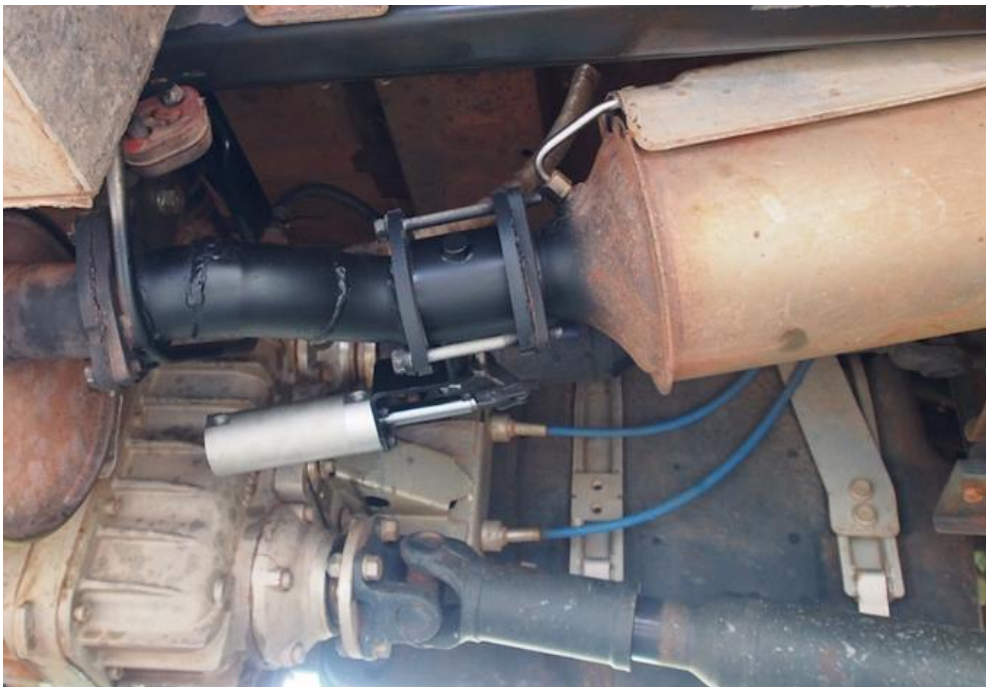
The Exhaust brake will hold back the Vehicle and Trailer combination on steep mountain grades so long as the engine is kept above 2500 RPM. The effect diminishes rapidly below 2500 RPM. However it is now possible to descend a hill in the same gear as was required to climb it. In conclusion the Exhaust Brake is not a 'brake' as such but effectively holds the vehicles speed downhill stopping the danger of a white knuckles brake smoking event, in short a very significant safety enhancement.

Gearing Dynamics 3" Exhaust Brake valve fitted to 55S17W

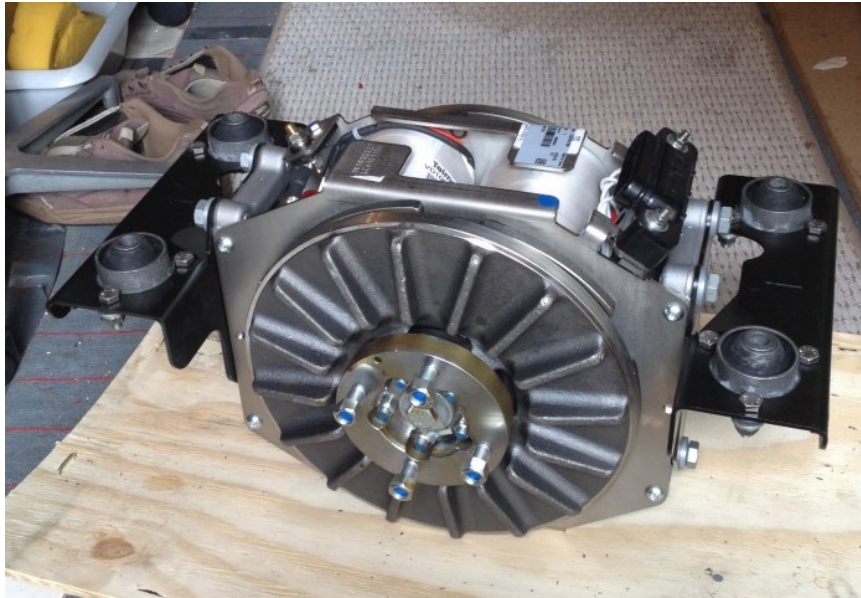
Retarder with Telma supplied brackets

The retarder is mounted between and below the two tubular chassis cross members, just forward of the rear axle. This section of the chassis is designed for mounting the hydraulic ram for a tipper-tray, so it is very strong. The approximate static load on either side of the chassis will be 35 kg. However, during maximum retarder braking this will change to an approximate down-force equivalent to 95 kg on one side and an up-force equivalent to 25 kg on the other side.
