COMPLEAT IDIOT'S GUIDE TO IVECO DAILY 4X4 55S17W

2020 REVISION

About this Book

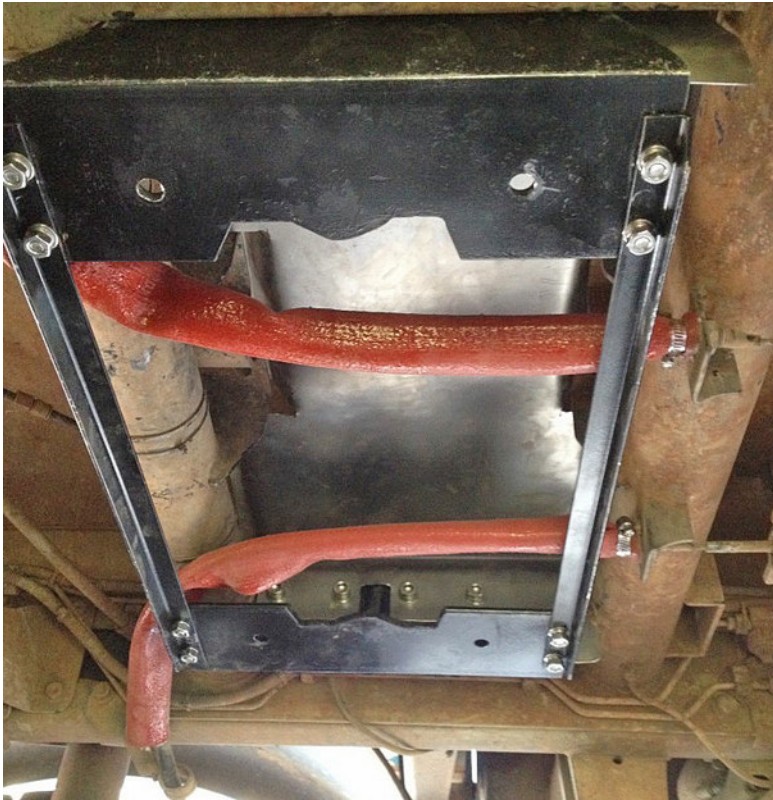
To allow for reasonable chassis clearances and to ensure the maximum retarder to rear axle prop-shaft clearance, the retarder has been mounted as far aft as possible. The vertical position has been a compromise between: the PTO prop-shaft angle, the clearance of the hand brake cables and the clearance of the rear axle prop-shaft. The hand-brake cables have a heat protection 'fire sleeve' fitted as a precaution to give them protection from the hot airflow coming off of the retarders rotors during extended retarder braking.

Bracket fitted with top heat shield and fire sleeve on handbrake cables

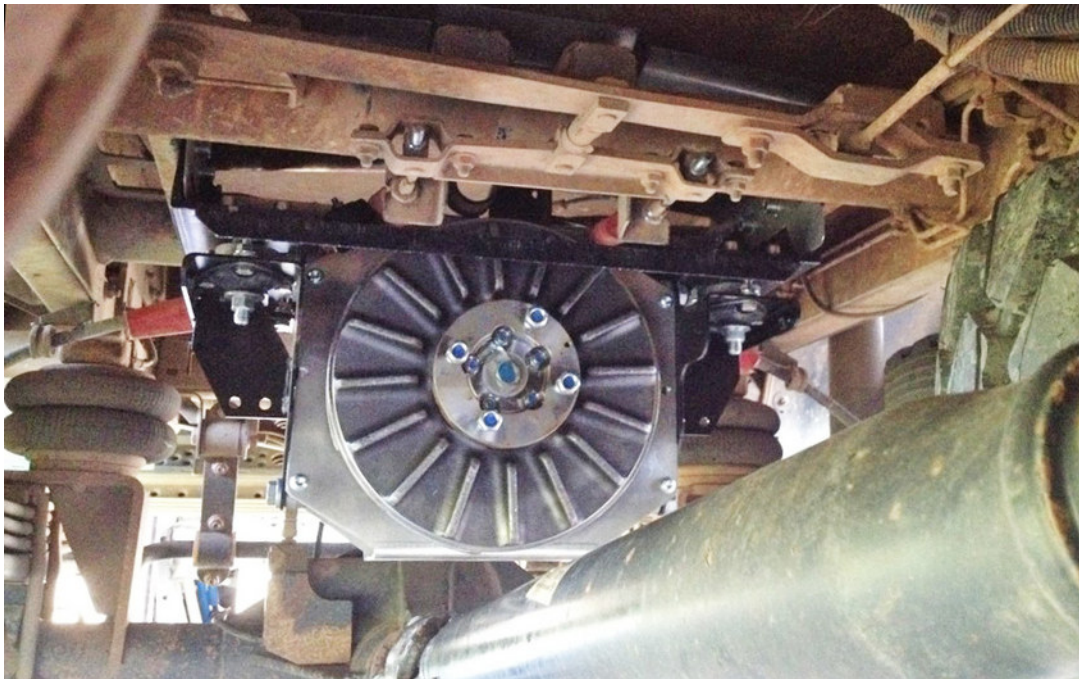
Retarder mounted in the chassis

To connect the retarder to the PTO, a complete front prop shaft is used. The front prop-shaft just happens to be the correct length and using it means that a spare front prop shaft is available should it ever be required in a remote area.

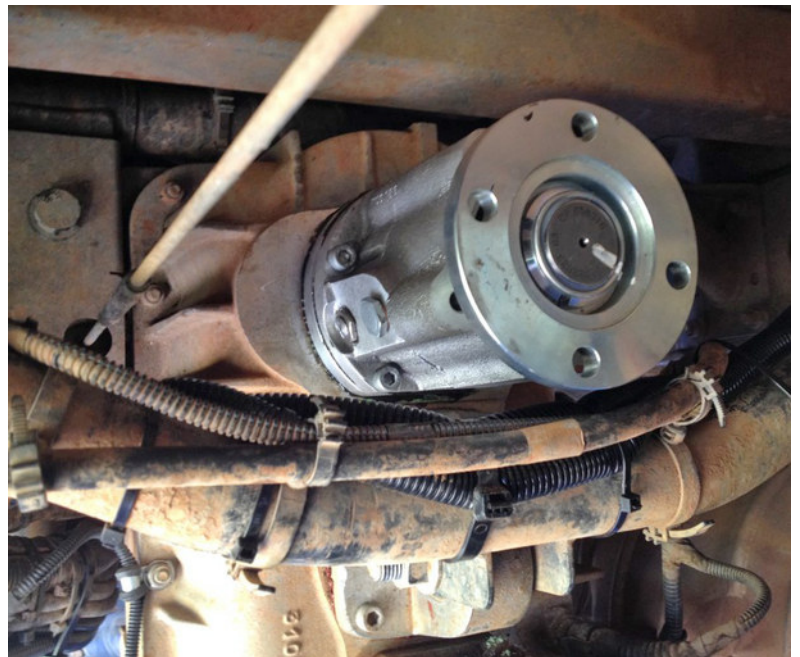
PTO installation

The electrical system consists of:-

1. the retarder with its 3 sets of electromagnets
2. a relay box to control the electromagnets in the retarders
3. a hand controller to select the braking force required
4. an indicator to show the braking force selected
5. a relay to activate the brake lights and disconnect the cruise control
6. an interface to detect ABS operation

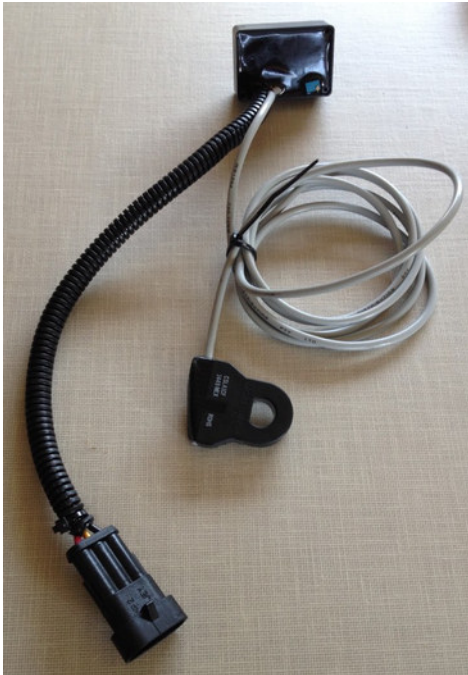
ABS power cable through current sensing module

Most ABSs have an output that is activated when the ABS is actively controlling the braking and this signal is used to turn off the retarder during the ABS event. Unfortunately the Bosch 5.3 ABS does not have this output so Marcus has designed and built an electrical circuit to monitor the current; this circuit uses a hall-effect induction loop around the power cable going to the ABS. During normal operation, the ABS draws less than a couple of amps. But when its valves and pump activate during an ABS event, this current flow increases to between 10 and 60 amps! The circuit detects this higher ABS event current flow and turns off the retarder until the ABS event is over. This circuit is powered from an 'ignition on' feed via a 5 amp fuse.

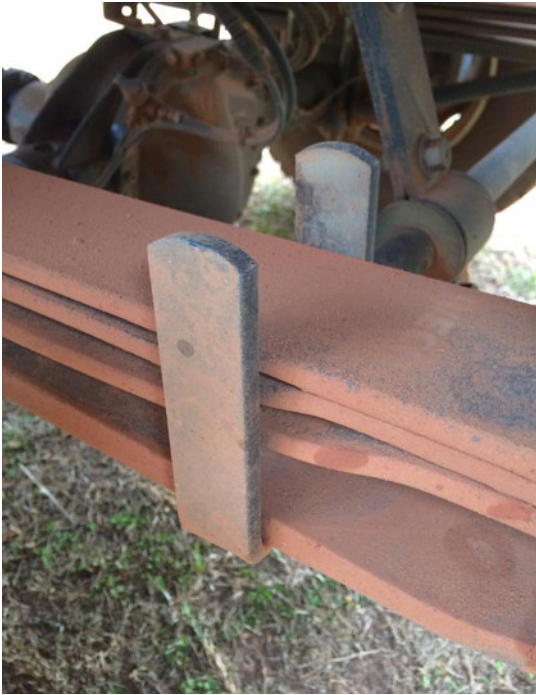
The suspension squeak is particularly annoying because the truck is relatively quiet and rattle free. The parabolic springs themselves are noiseless by design, as are the poly-urethane shackle bushes. The cause of the rattle is usually the rear spring keeper rubbing on the edge of a spring leave but in some cases the front spring keeper can also be at fault.

rear spring keeper

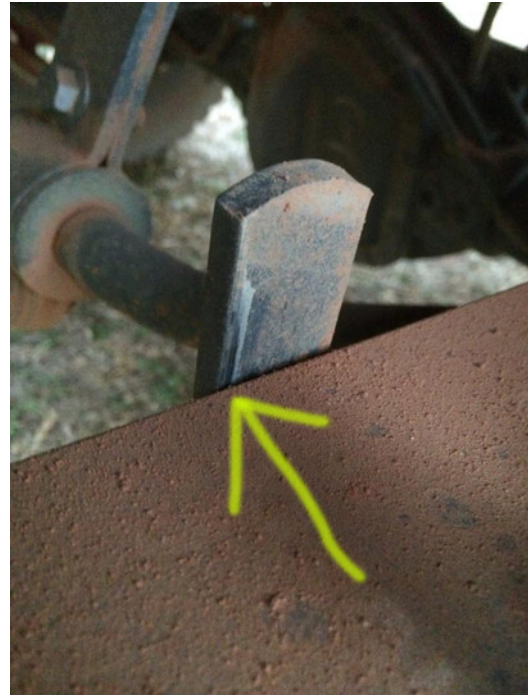
evidence of rubbing

The keeper can be spread apart to prevent touching but then its purpose is meaningless, over time the leaves will move and the squeak may possibly reappear.

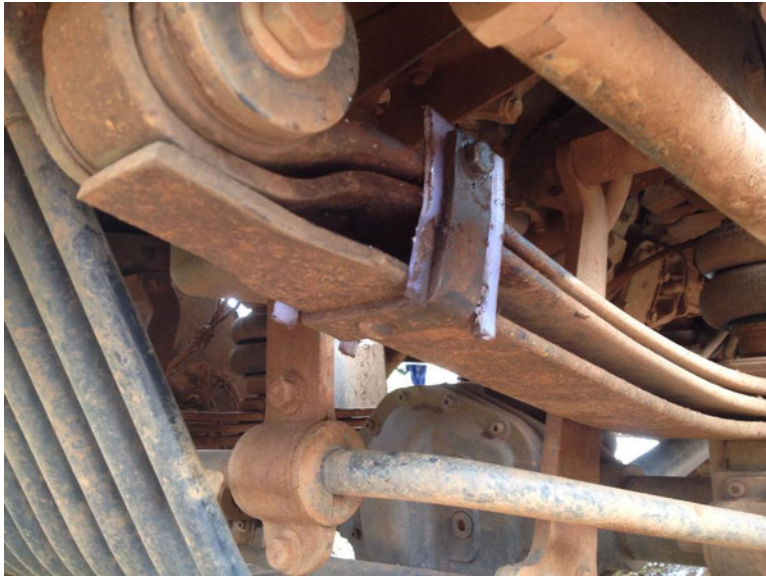
DIY squeak mitigation strategies include the use of ubiquitous kitchen chopping board and 32mm poly pipe.

Kitchen chopping board on front keepers

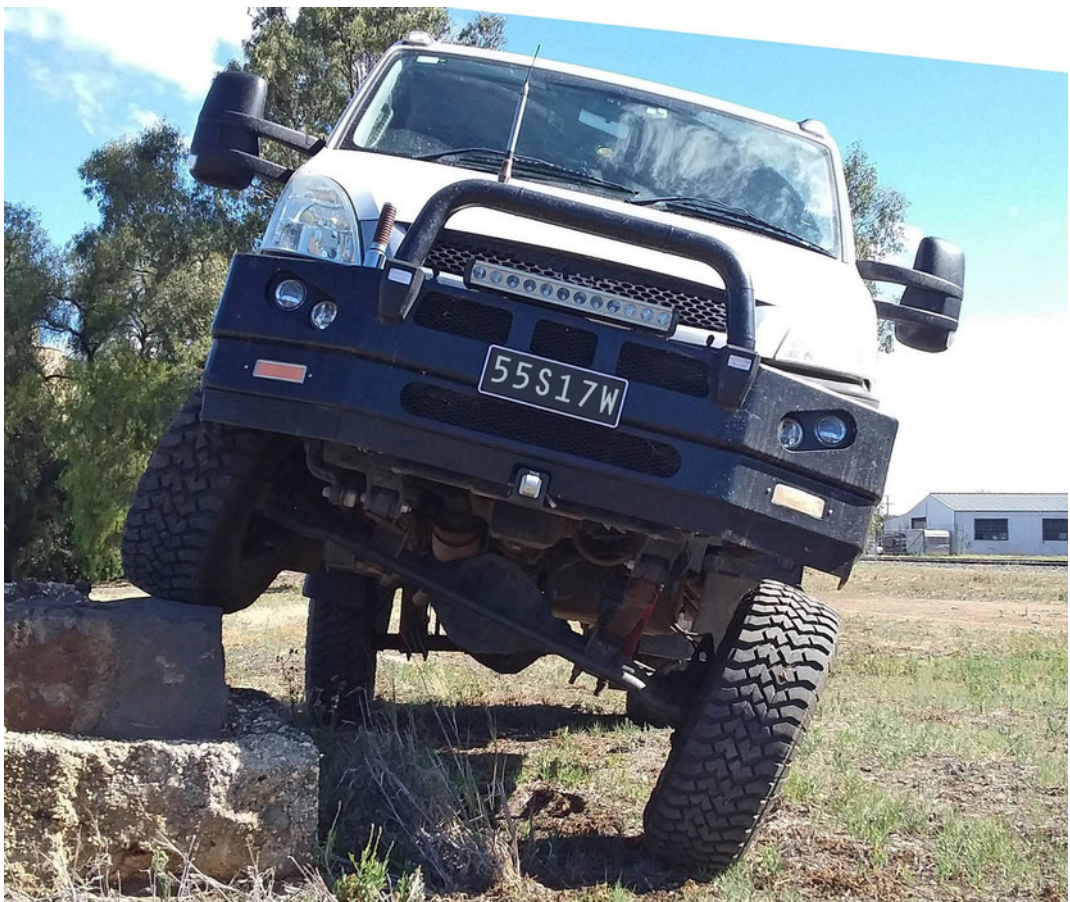
Standard suspension with front roll bar removed (for off road use only)_

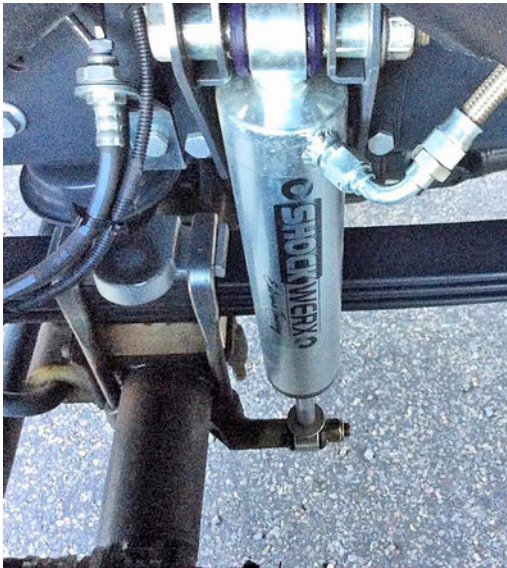
Shock Werx remote reservoir gas shocker

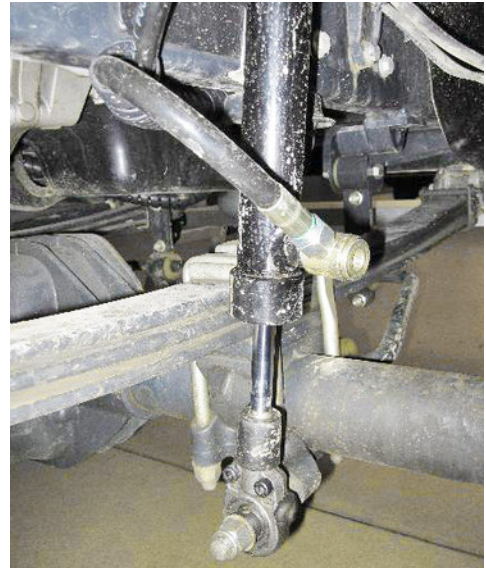
Citroen style hydraulic / accumulator

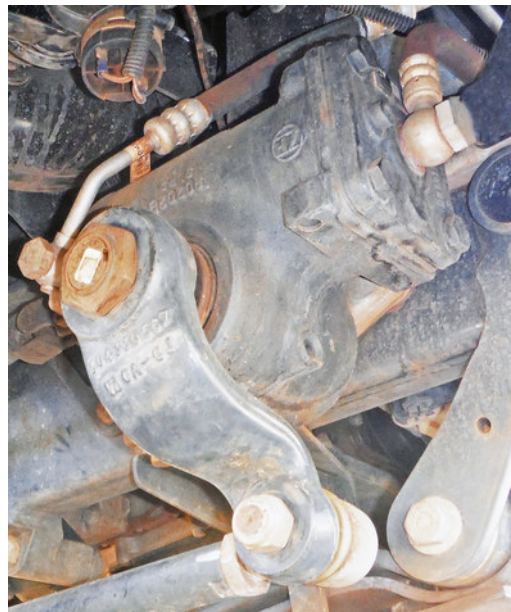
ZF 8090-955-206 Steering box

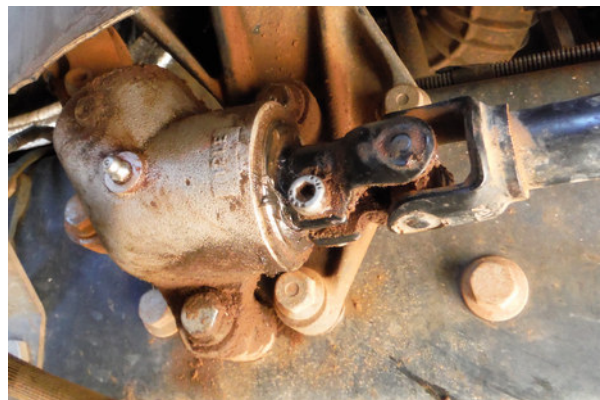
The steering shaft then changes direction through a 130° bevel gearbox, through another set of universals and a splined slip joint and finally into the Steering box.

The bevel box is fitted with a grease nipple, as are the upper and lower swivel housing bearings, (King Pins). The 5 grease nipples on the steering plus one on the hand brake bellcrank gives a total of only 6 grease nipples on the entire truck.

130° bevel gearbox

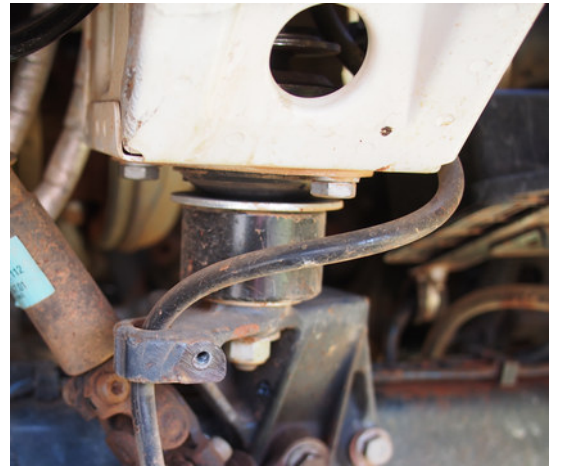
Cab Front flexi mount

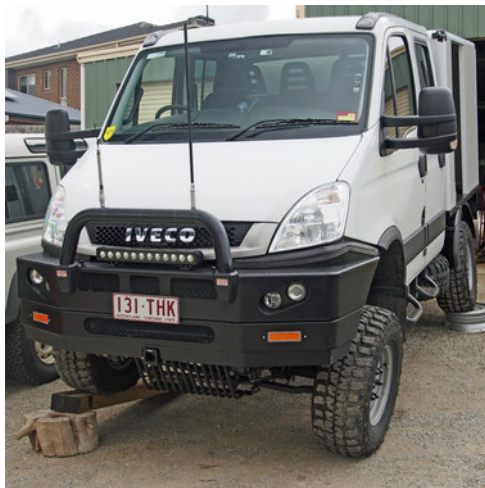
To demonstrate the degree of chassis flexibility refer to the image at left, front and rear opposite wheels are safely positioned on ramps to simulate one possible scenario of a mild off-road driving condition, the axles are slightly articulated, causing the chassis to flex or twist a little..

Considering the bullbar is fixed to the front of chassis, it will move as the front of chassis moves. The Cabin is on flex mounts which equal out the chassis flex across its 4 mount points, with all that in mind check the disparity between cabin to bullbar clearance indicated by each gap behind the headlight. Now extrapolate the flex through to the rear of chassis and the amount of flex becomes more significant.

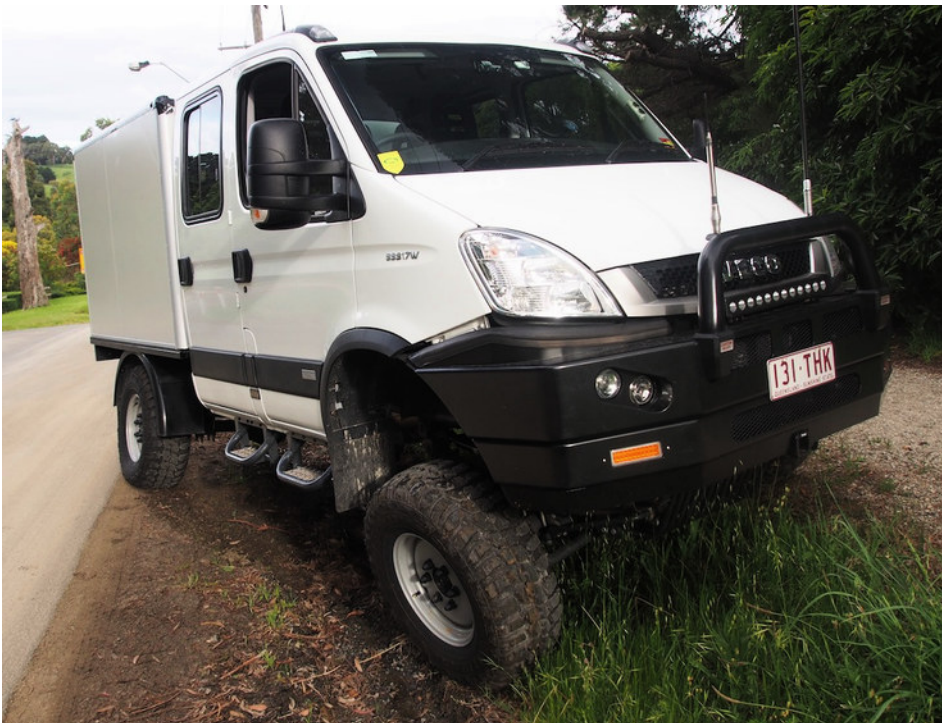
here is the amount of flex taken up by rear subframe mount, (truck on blocks prev. page)

Not a bad amount of flex for a standard suspension setup

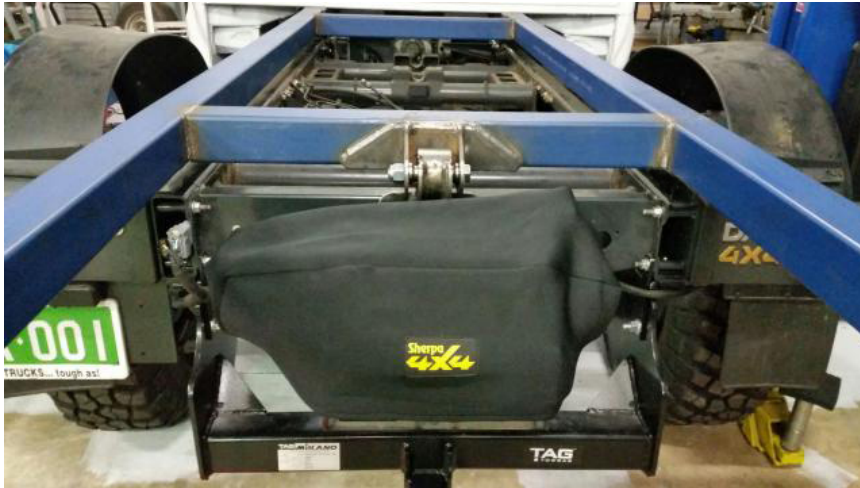
rear of EVA 3-point mounting system

Bodywork fixed to the rear of the 55S17W should be mounted on an independent rigid subframe. The subframe should be fixed in such a way that torsional movement of the chassis is not transferred to the subframe. Either by the use of a 3 point mounting system or via other suitable flexible couplings.

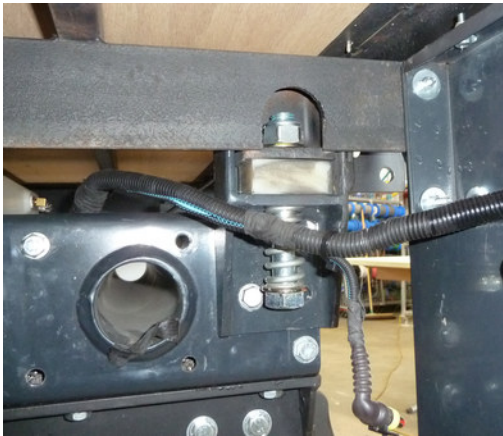
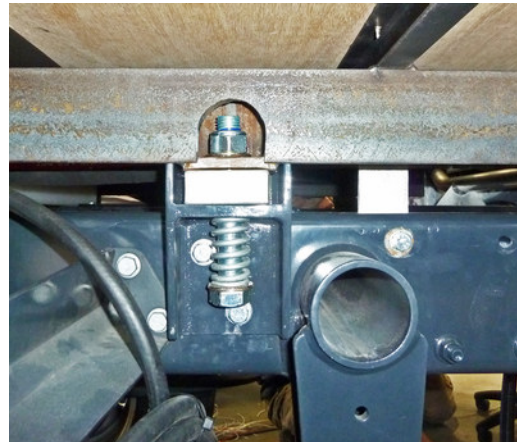
Traveltrucks kinetic mounting system uses multiple sprung mounts.

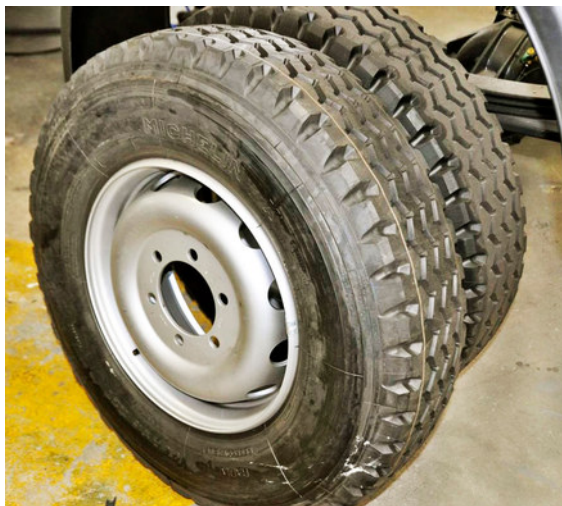
17.5" and 33" XZY road tyre

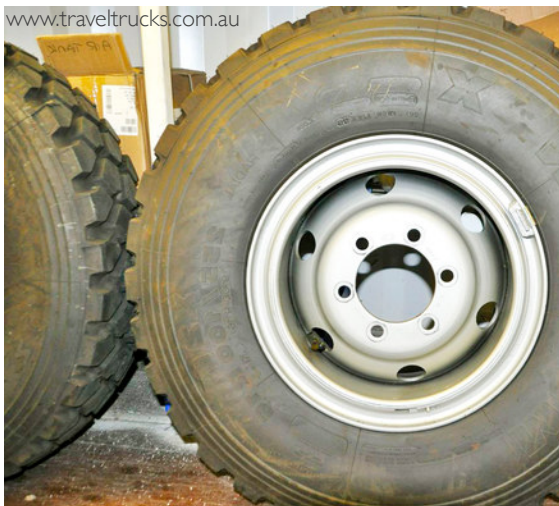
The Iveco off road tyre option uses 255/100 R16 Michelin XZL (36" dia) on 16 x 6.5 Tubeless Split Rim.

16" split rim with 36" XZL off road

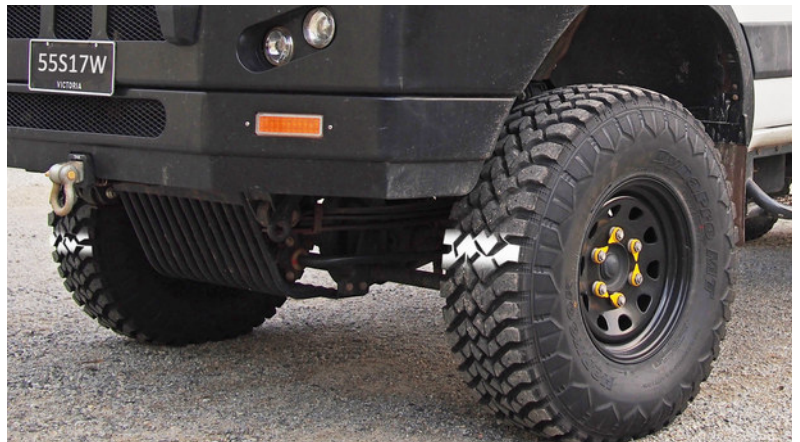
If the paint is worn evenly the tyre pressures are perfect for that loading.

If the paint is worn away in the centre but visible on the edges the tyre is over inflated.

If the paint is worn on the edges but visible in the centre the tyre is under inflated.

To determine the absolute correct tyre pressure to get the most life out of your tyre, set your tyres to what you guess might be the correct pressure. Paint a line across the tread of each tyre and wait to dry. It should look like you had an accident with a line marking machine.

Drive on a sealed road for about 10km then check the paint marks (different distance for different paint type or road surface - you will get the idea).

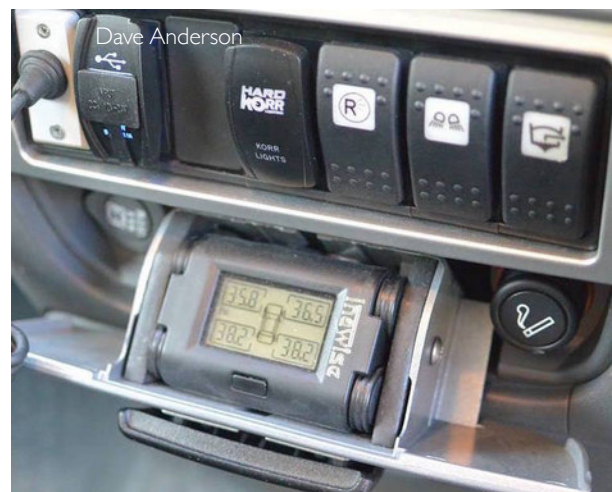
Each tyre to be monitored contains a pressure sensor transmitter. On the cheaper systems the transmitter is on the valve cap, convenient but problematic. The better systems have transmitters adhered to the rim inside the tyre or as part of the valve stem.

"Inawise" TPMS fits neatly into Ash Tray

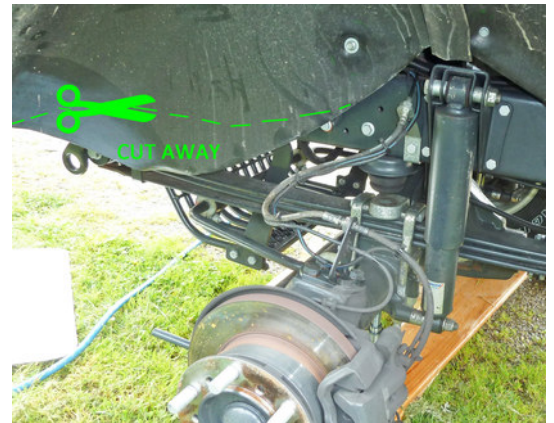
The bottom edges of the inner mudguards will need trimming to stop larger tyres rubbing or catching on full lock, especially in reverse. Being thin plastic sheet they can easily be cut with good scissors. (be careful not to cut any unseen lines or wires behind).

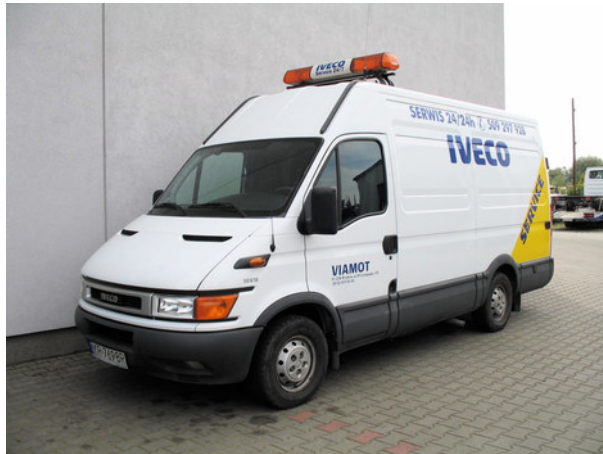
The Windscreen is Iveco Part Number 500316402, Pilkington 3471AGN.

Same Glass used from 1999 - 35S13 shown

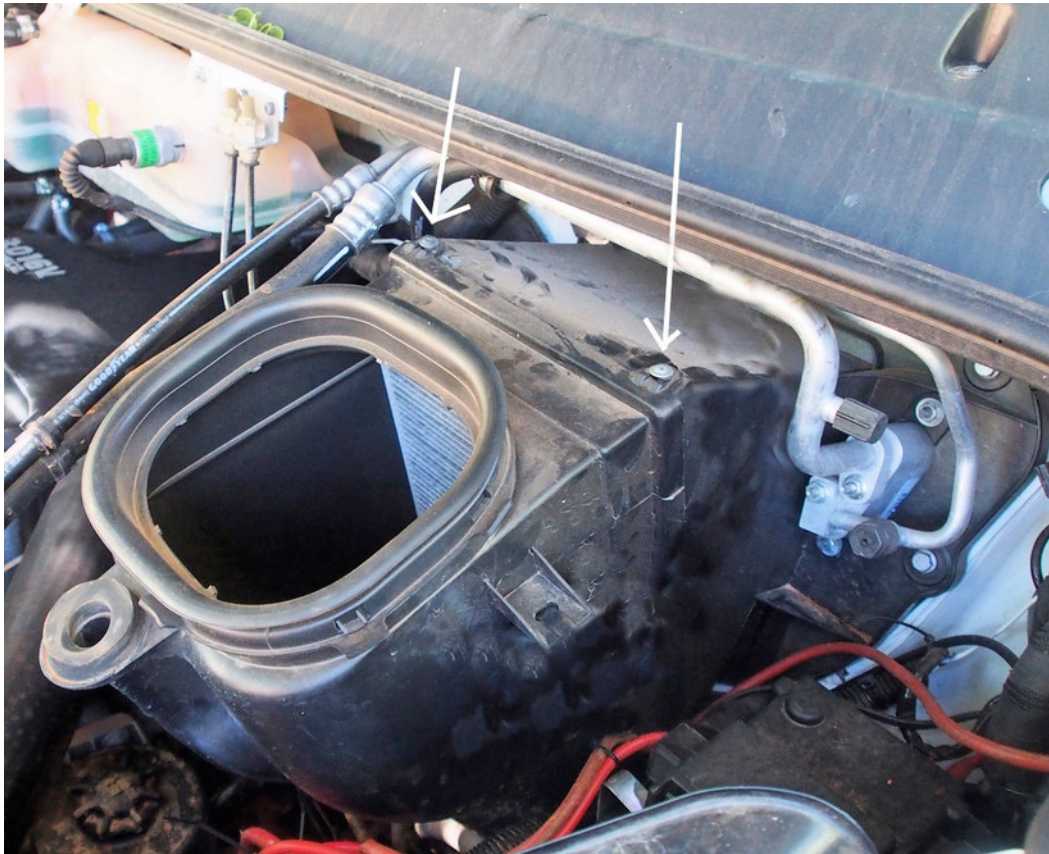
The filter element is easily replaced by simply unscrewing the two phillip head screws indicated by arrows in the image above. The Air hood lifts off from two slots in the housing and the element is swapped in a matter of minutes.

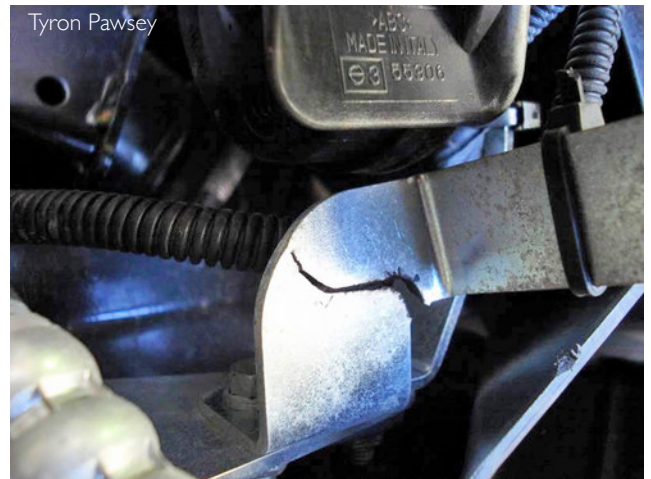
To locate horn sit on the floor in front of the drivers wheel and look up behind the low beam light.

horn bracket same as 2WD

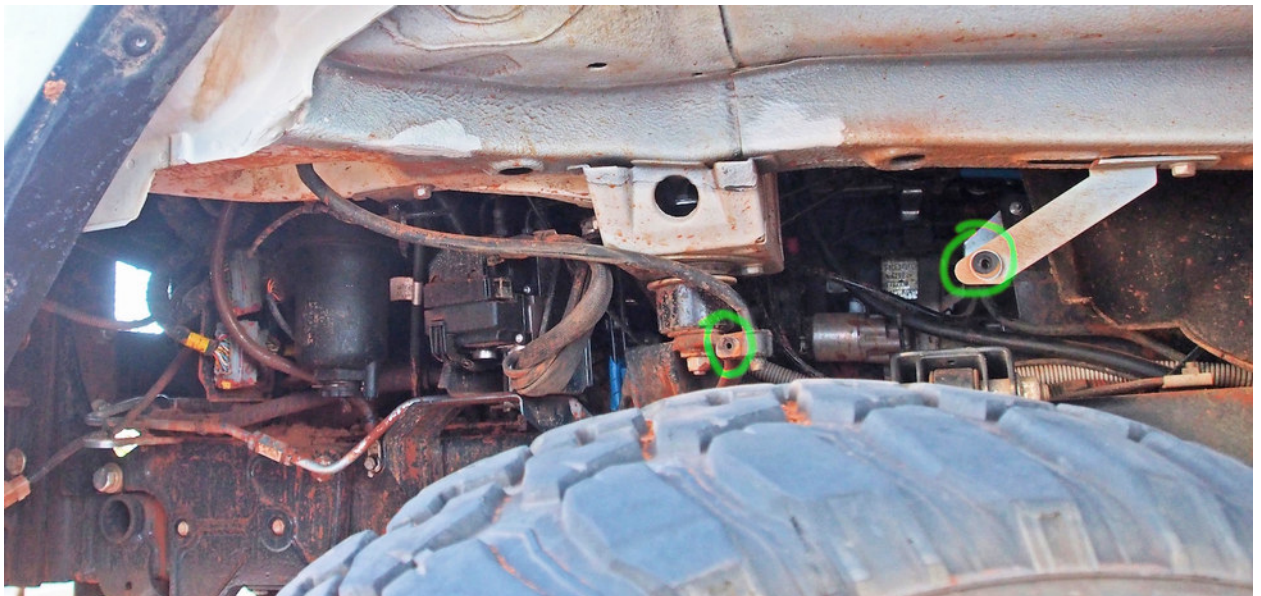
The flimsy plastic inner "mudguards" are 4x4 specific, labeled as 'engine protection' in the parts manual need regular removal to gain access for maintenance and inspection. The fixings routinely come loose and have been known to fall away, its prudent to use larger washers and some thread binding compound (eg. loctite) on the fixings.

left inner guards removed, same fixing points highlighted

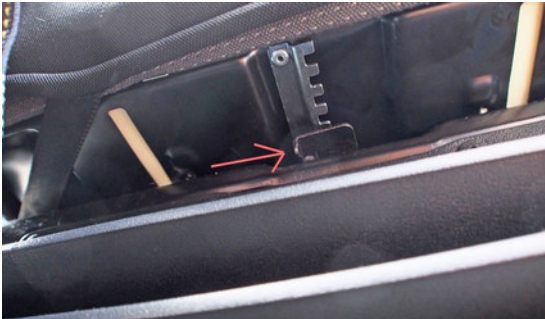
push lever in direction indicated by arrow,

There actually is a top secret adjustment to move the seat squab (base cushion) forward about 30-40mm. One small adjustment makes a huge difference, the seat is way better; goodness knows why its not in the manual, perhaps some OHS BS about jamming fingers ??

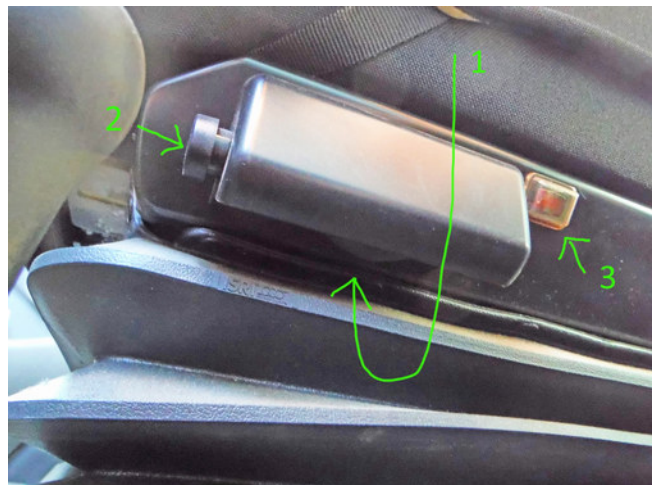
Refer to the bottom left image. It shows the Lumbar pump at the front left bottom of drivers seat, passenger suspension seat has same on the front right (as seated).

- (1) Air pump bulb just visible in photo
- (2) Pressure release button
- (3) Bum Warmer switch

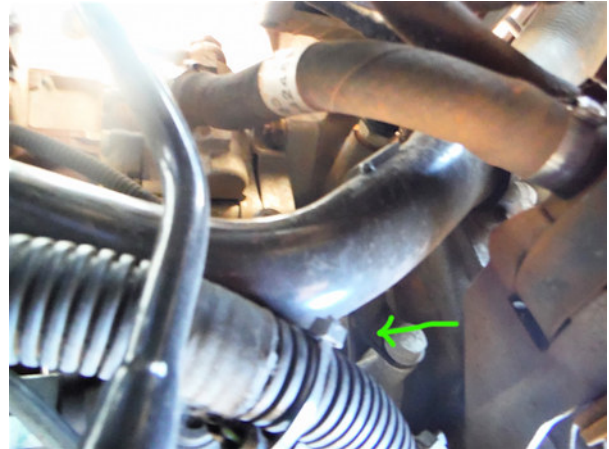
CableTie tang too close to coolant hose

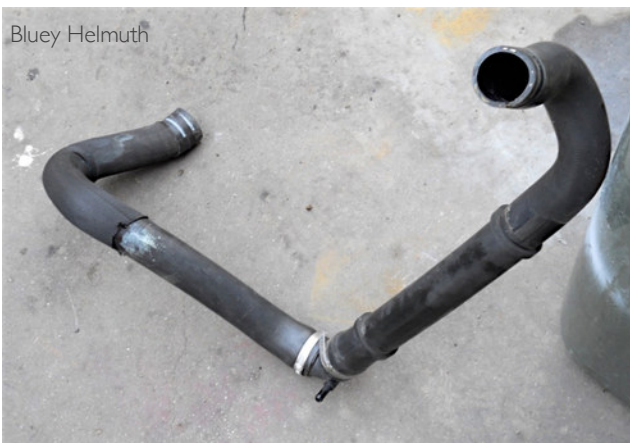
Highlighted at in the image at left is the location of a cable clamp with sharp edges that rub directly onto the hose under the coolant header tank. The hose has been protectively wrapped in some inner tube rubber by the owner & cable tied in place.

Radiator hose / Cable Tie rub through

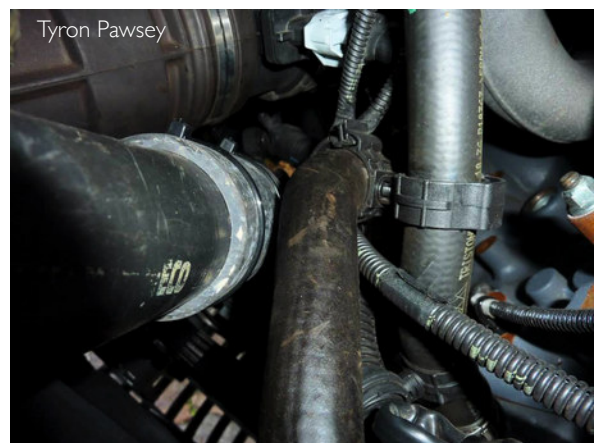
fixed using rubber shroud around hose

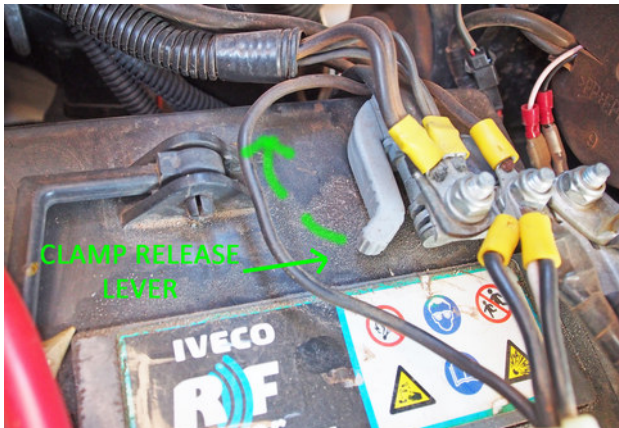
The troublesome Negative battery clamp has a cam action release lever, rotating anti-clockwise will release battery cable clamp but it may be the case that some aftermarket wiring needs to be removed from the clamp to allow battery egress.

These cam lock clamps are known to cause starting problems, best replaced by an aftermarket battery clamp.

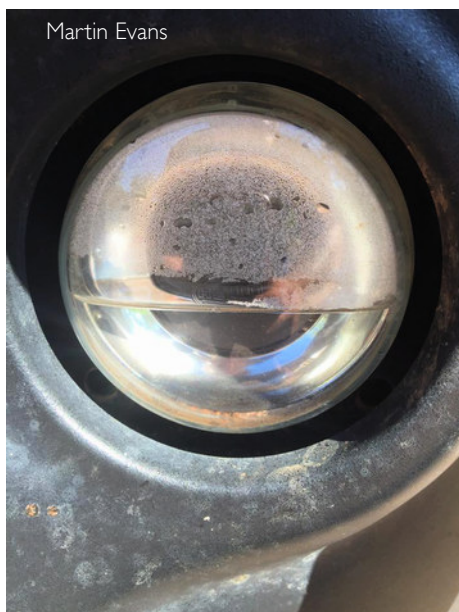
The small Low Beam and Fog lamps in the bumper bar are a commercial Truck / Bus 90mm Halogen Headlamp. Not entirely suitable to 'off road' use as can be seen by the example at left after having engaged in some Arnhem Land creek crossings. Not particularly an Iveco 'quirk' as time spent wading in any vehicle with non-sealed beams do suffer the same fate.

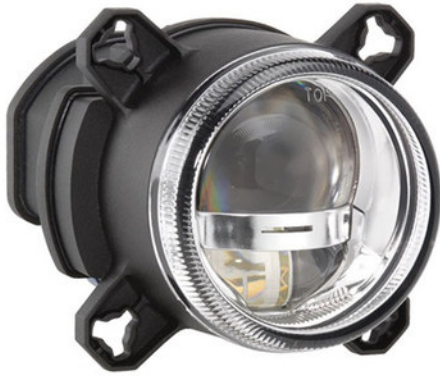
The ADR approved Narva 71988, shown at left is a direct replacement for the Hella Halogen H7 Low Beam unit in the 55S17W.

The LED Low beam is huge improvement over the existing Halogen, in reliability, much lower power consumption and most importantly - light output.

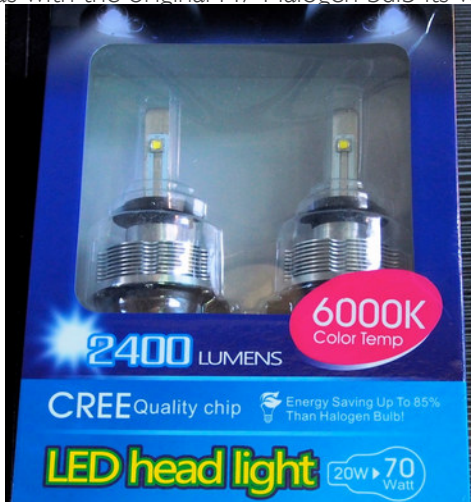
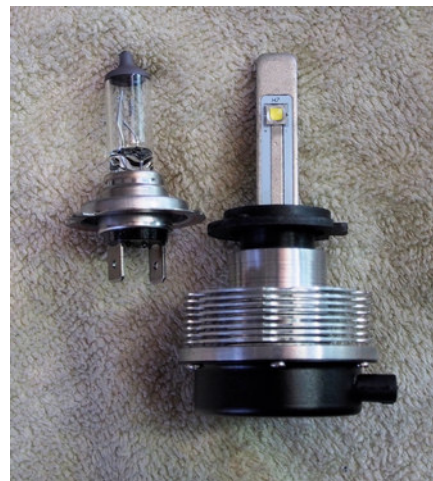
H7 Halogen vs H7 LED

Cree LED technology is seriously good. Superior lighting for lower power consumption. A variety of H7 LED bulbs, mostly from China, are available online. The example shown here is bulky but has heat sink cooling and does not need a fan or control box. It is easily retrofitted to the Iveco 4x4. It has proven reliable in outback conditions as with the original H7 Halogen bulb its weakness would be submersing it in deep water.

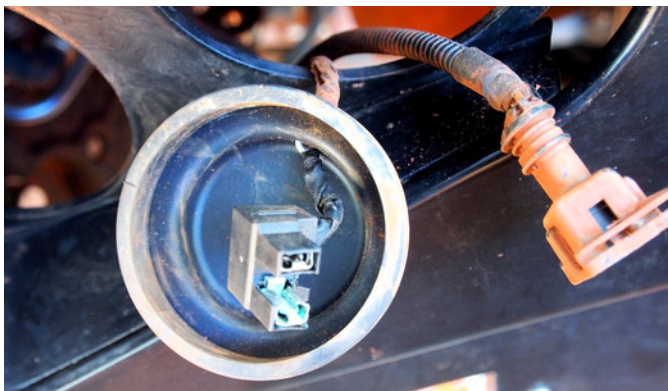
Corrosion on original Low Beam headlamp socket shown at left, This vehicle has never been in salt. Reminder to spray everywhere with water repellent if you go near the beach. Salt Water Sucks !!

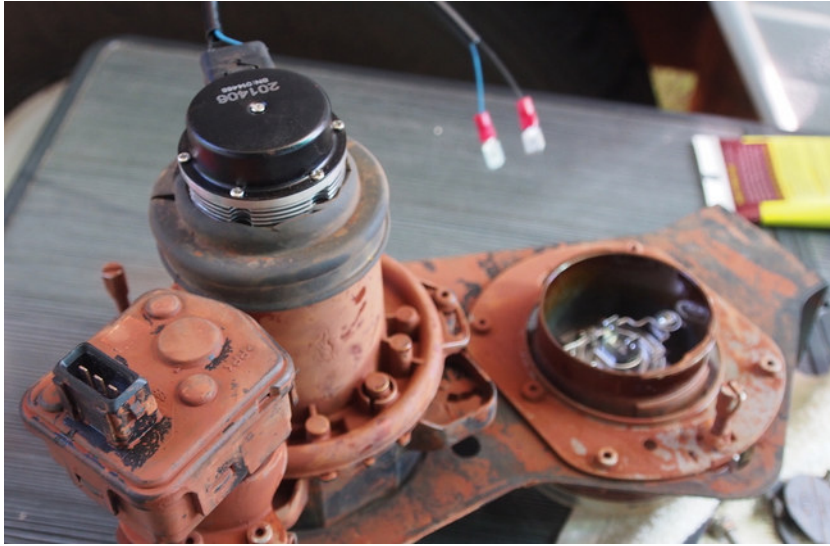
H7 LED mounted in Hella housing

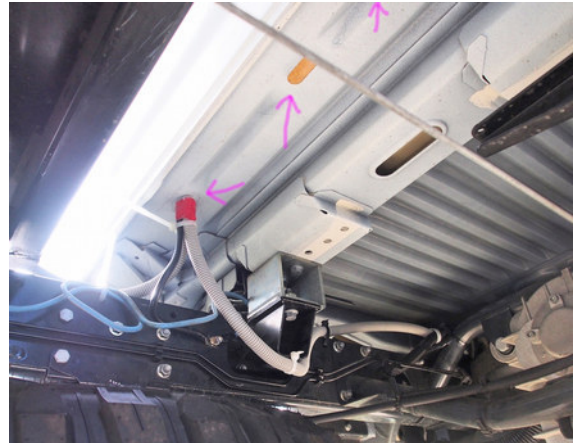
possible cable entry holes under rear floor

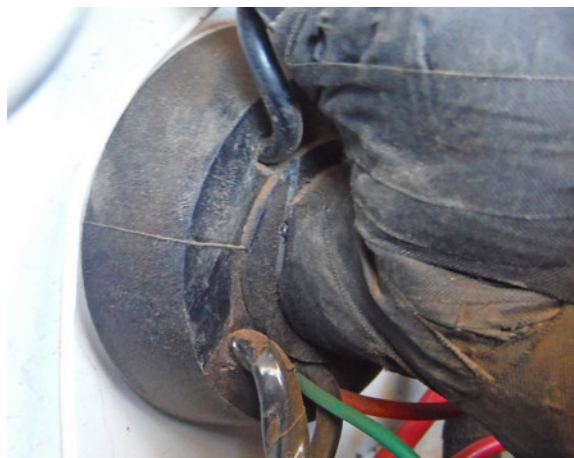
main loom firewall grommet

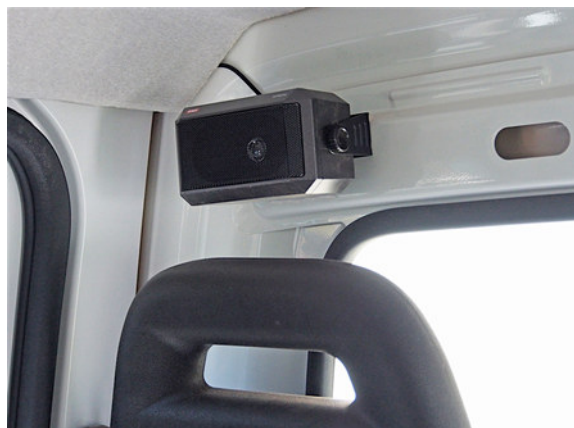
rear speaker cabling - too easy

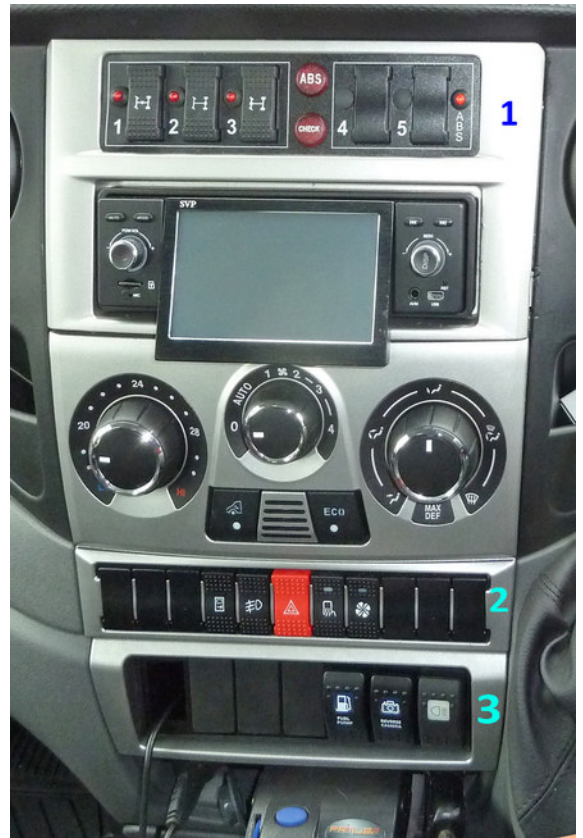
Iveco use their own proprietary switches, the Diff Lock switch panel (1) at top is mounted inside a standard Single Din enclosure. The standard Fiat / Philips radio uses another Din enclosure. The radio in the console at right has been replaced with an aftermarket radio / GPS.

The 10 switch locations in panel (2) will only fit Iveco switches, the Red Hazard switch is slightly larger will only fit the centre slot. An Iveco factory accessory light switch is available, to fit the blank switch positions. Part number 5801465646.

Switch panel (3) is an aftermarket Single Din 7- Carling switch panel. There are numerous carling switch styles available, with a plethora of 4x4 related icon printed on them.

The Diff Lock switches can be moved south to fit the spare proprietary switch locations in panel (2) making the way clear to fit a Double DIN enclosure panel for a 7" GPS display or entertainment system.

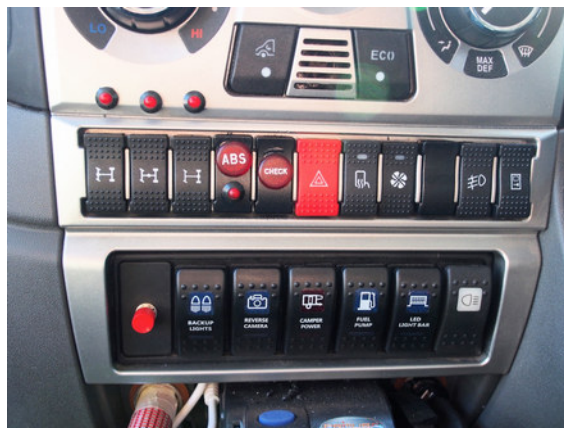
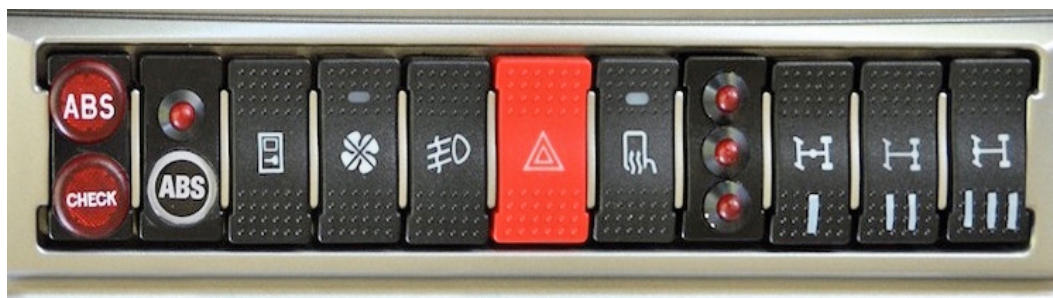
One of the proprietary blanking covers makes a great location for the Centre, Rear and Front diff-lock-engaged indicator lights.

The entire switch control panel is held in place by 3 screws, two are obvious under the bottom 1Din cover (the original Din buckets can be easily removed) the third screw is hidden under the centre 'fan control' knob which simply pulls off.

A few DIY examples are shown here. The end result is a much better looking and more functional dashboard.

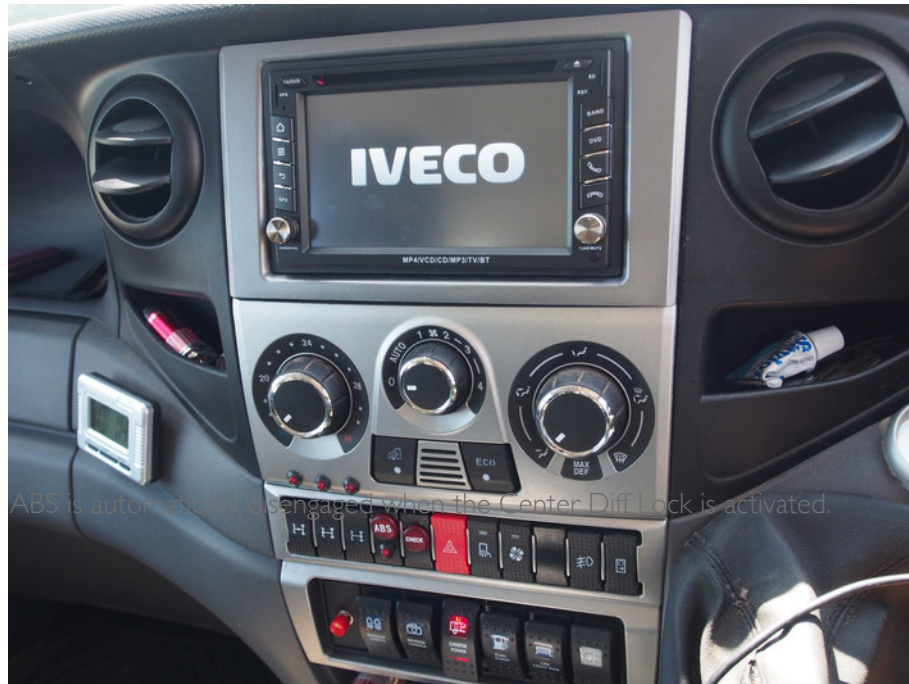
Erisin 7610 Head Unit fitted - note: panel colour mismatch is not an issue

The Erisin 7610 Head Unit (Nissan Clone) is a great choice, it runs Windows CE so is compatible with OziExplorer and Hema Maps / Vicmaps etc, and includes the Iveco logo as one of the default startup screens. The way technology is that model is probably already obsolete. When deciding on a head unit, also consider one without a CD/DVD player as there is limited room for the bulky wiring needed behind the radio, a head unit without an optical drive should be shorter; another often overlooked consideration is to specify a unit with a non-glossy screen.

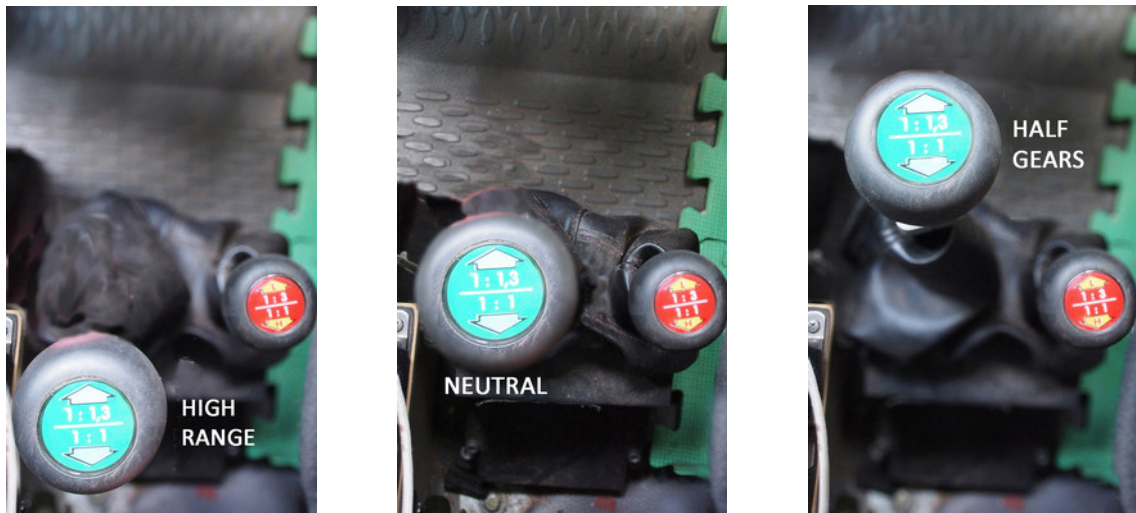
Half gears are a nice feature of this vehicle, No other 4x4 in Australia has such a device. The "Half Gear" (under-drive) is useful when driving uphill (or downhill) with many bends or on rough roads when towing. The half gears have a synchro-mesh and can be changed with the vehicle moving by pressing the clutch pedal and shifting the Green lever forward. There is a Neutral position between High Range and Half Gears. The gear change is stiff to begin with but will loosen with use and time. Do not force the gear change.

Low Range may be used for slow manoeuvring when "On-Road" hard surfaces, for example reversing a trailer up a steep driveway, boat ramp etc. to avoid riding the clutch. Never change into Low range (Red knob) whilst moving.

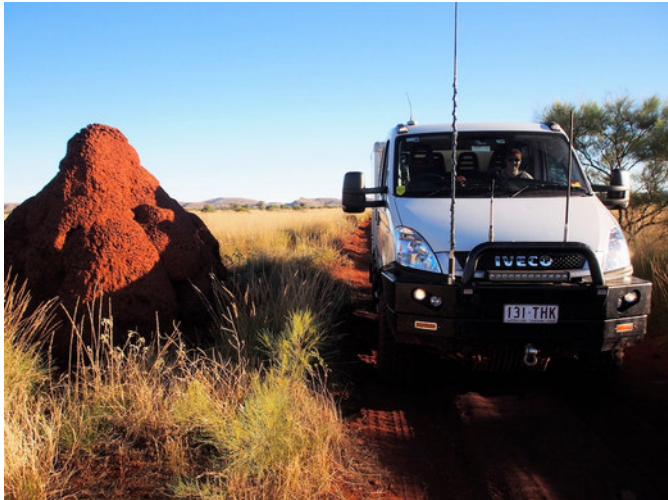
Dry grass flashpoint is about 250°C, The DPF operates at 750°C+

You have bought a Four Wheel Drive vehicle in "Good Faith" with every expectation that you will be able to use it in "Off Road" conditions, including driving through, stopping on and even setting up camp on grass, leaves, pine needles etc. Driving through Spinifex grass is almost unavoidable if touring Outback Australia.
